NO START—IN DAMP WEATHER WHEN WIPER SWITCH IS LEFT IN INTERMITTENT OR LOW SPEED POSITION—CONTOUR/MYSTIQUE EQUIPPED WITH V6 ENGINE AND ALL COUGARS	Article No. 00-18-6

FORD: 1998-2000 CONTOUR

MERCURY: 1998-2000 MYSTIQUE
1999-2000 COUGAR

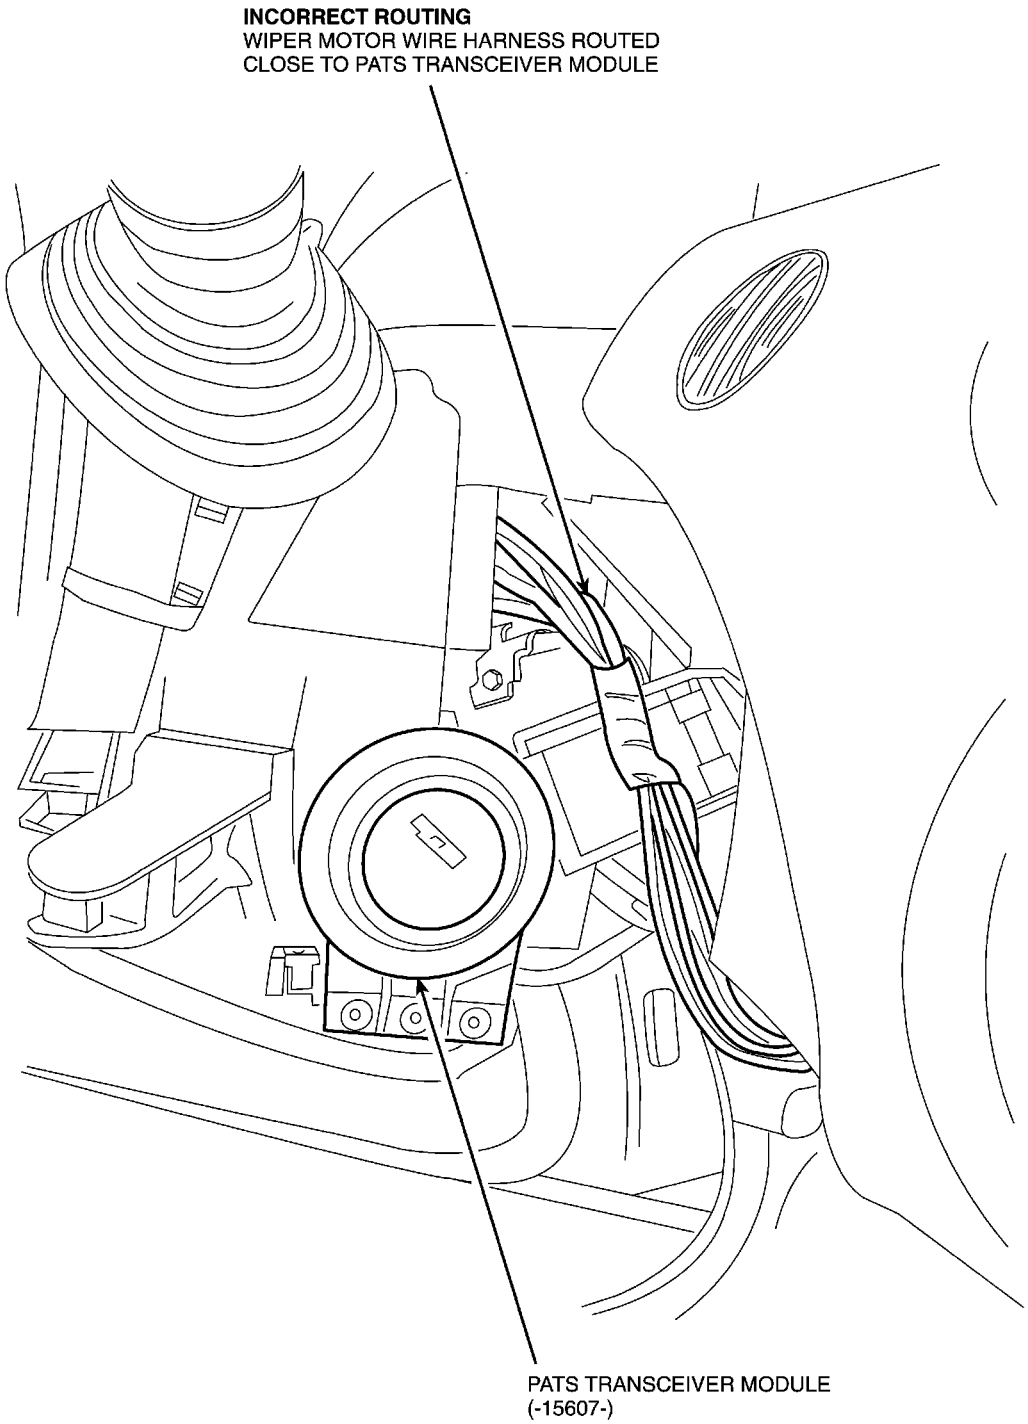
Figure 1 - Article 00-18-6

Some vehicles may exhibit a no start condition when the wiper switch is in the INTERMITTENT or LOW-SPEED setting during vehicle start-up. This no start condition does not occur if the wipers are set to OFF or HIGH-SPEED during vehicle start-up. This may be caused by the wiper motor wiring being routed too close to the Passive Anti-Theft System (PATS) module.

WIPER MOTOR WIRING HARNESS ROUTING
RELATIVE TO PATS TRANSCEIVER MODULE

Inspect wiper motor wire routing near PATS transceiver module. If the wire routing is close to the PATS transceiver module as shown in Figure 1, tie strap the wiring to the steering column as shown in Figure 2. Verify that vehicle starts with wiper motor set to INTERMITTENT and LOW-SPEED. If vehicle does not start under these two conditions after moving the wire harness, replace Wiper Motor -17508- with F7RZ-17508-AA. Refer to the appropriate Workshop Manual for wiper motor replacement procedure.

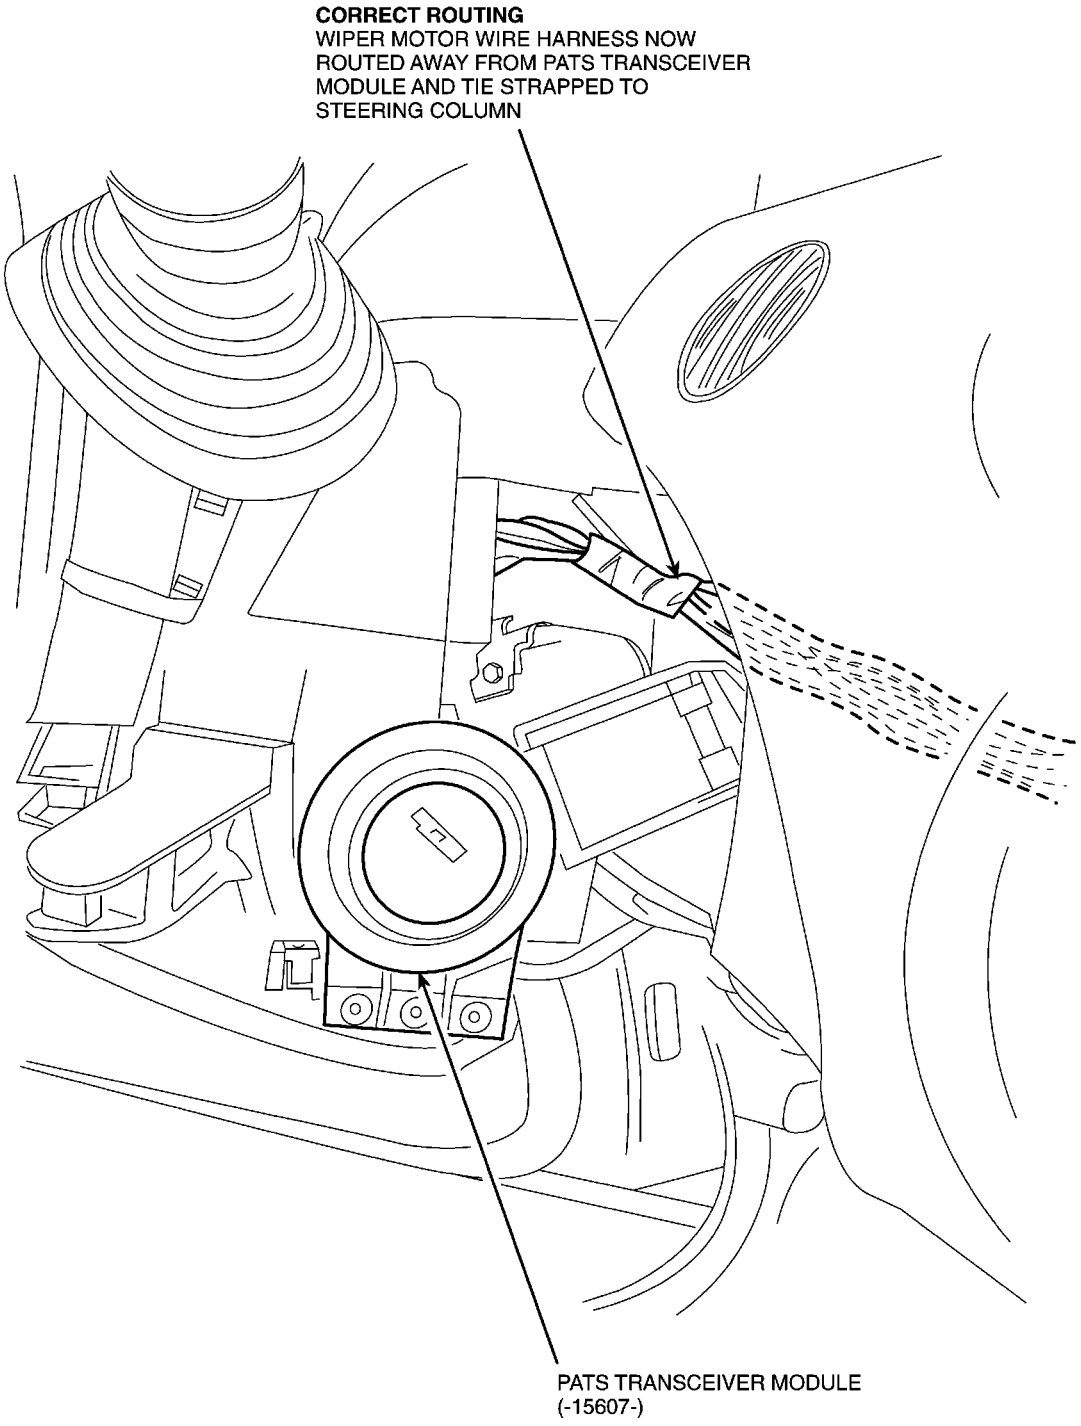
Figure 2 - Article 00-18-6

WIPER MOTOR WIRING HARNESS ROUTING RELATIVE TO PATS TRANSCEIVER MODULE

CORRECT ROUTING
