INTERIOR—A-PILLAR TRIM WARPED—VEHICLES BUILT FROM 8/7/1998 THROUGH 8/26/1999	Article No. 99-21-6

FORD: 1999-2000 WINDSTAR

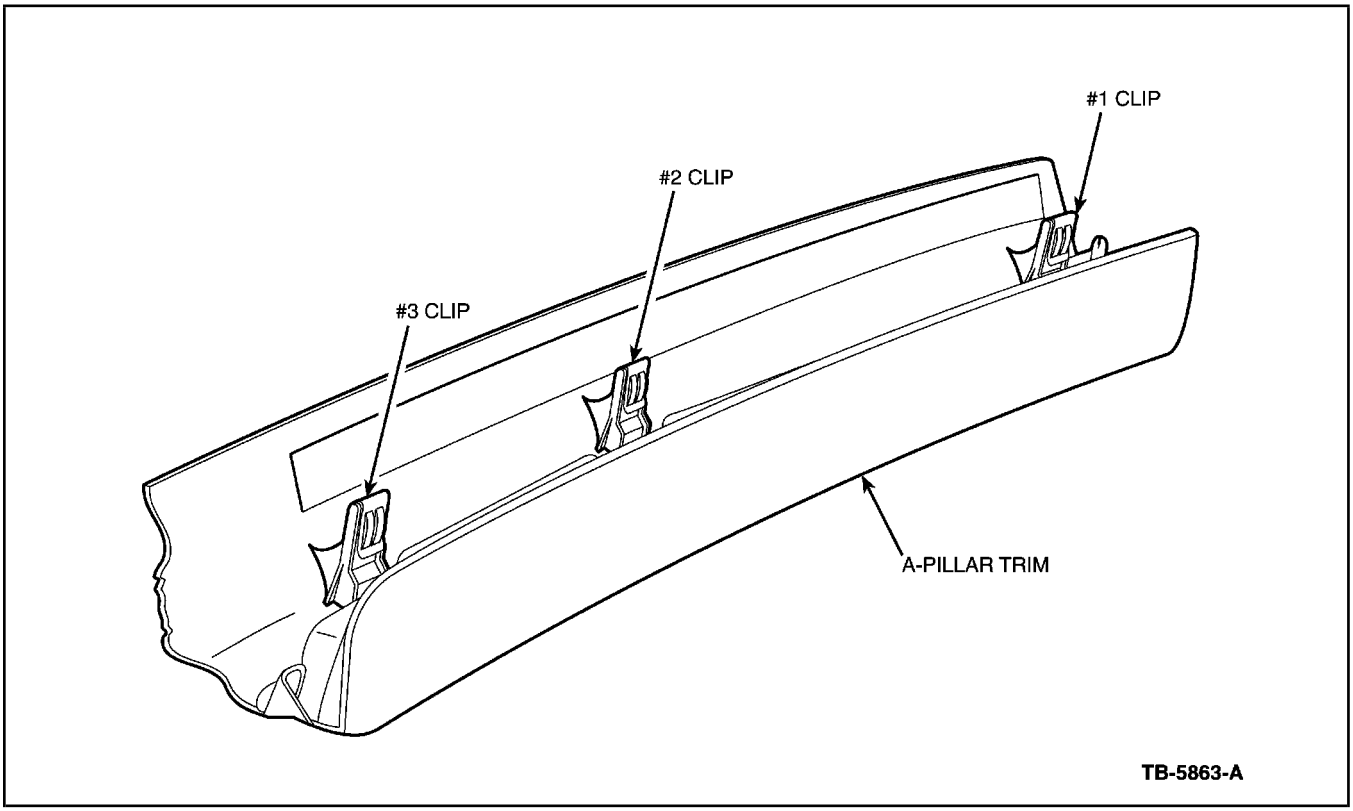
Figure 1 - Article 99-21-6

The A-pillar trim may become warped as a result of stress from the expansion and contraction of the material due to temperature changes.

1. Remove the warped A-pillar trim from vehicle.
2. Obtain a new A-pillar trim from service stock.
3. Remove the #3 retaining clip (bottom of trim piece) by cutting off the plastic sail area (Figure 1).
4. Cut two slits approximately 10mm long into the plastic base of #2 clip (#2 clip is located middle of trim piece) at the two areas indicated (Figure 2).
5. Install the reworked trim piece onto the A-pillar.
