2001 ESCAPE STEERING WHEEL RETENTION NUT

AFFECTED VEHICLES: CERTAIN 2001 MODEL YEAR ESCAPE

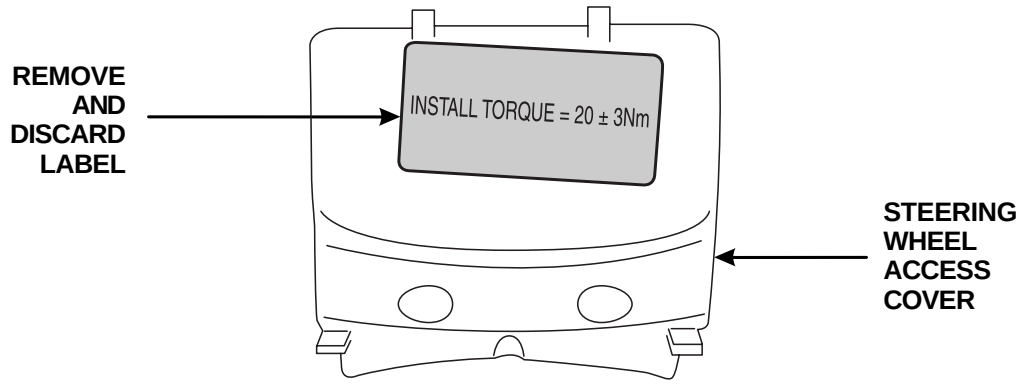
FIGURE 2

2. **CAUTION: The torque information label located on the steering wheel access cover contains inaccurate information. This label MUST be removed and discarded.**

LABEL CONTAINS INACCURATE INFORMATION

Remove and discard the torque information label. See Figure 2.

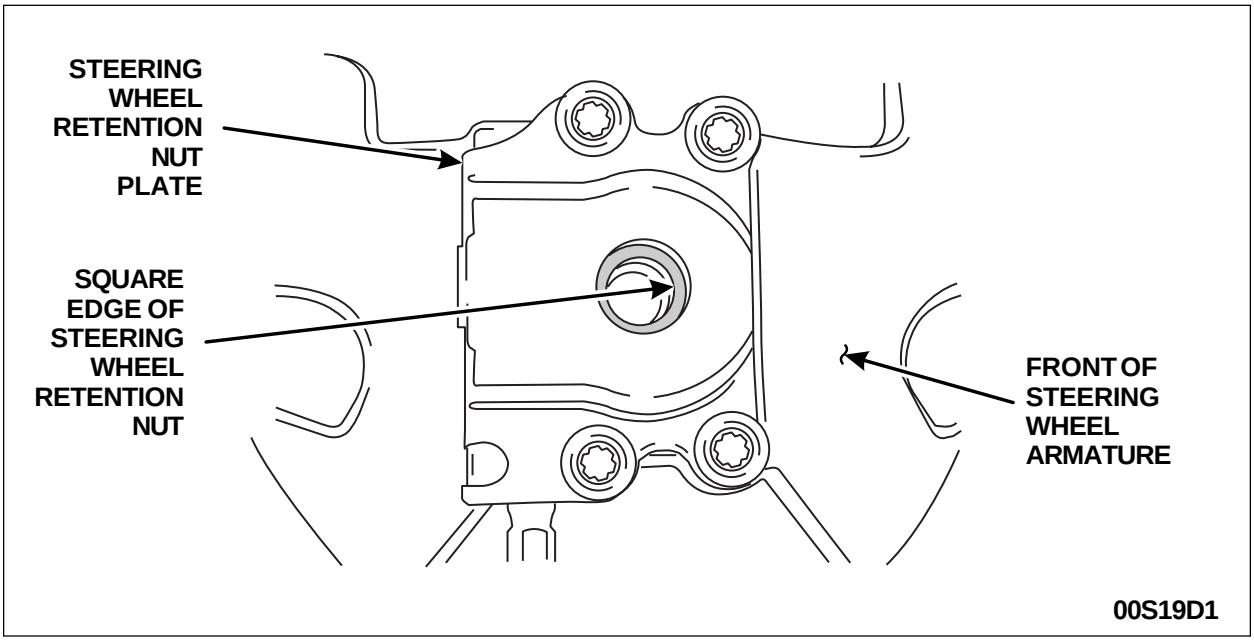
FIGURE 4

Inspect the steering wheel retention nut. The surface of the steering wheel retention nut should form a square edge with the threads of the nut. See Figure 4.

B. If a tapered edge is found, the steering wheel retention nut is NOT correctly installed. The steering wheel armature AND steering column must be replaced.

A. If a square edge is found, the steering wheel retention nut is correctly installed.
   - Install a ***new*** steering wheel armature. Tighten the nuts to 12 Nm (9 lb-ft).
   - Install the steering wheel rear cover. Tighten the screws to 2 Nm (18 lb-in).
   - Install the steering wheel. Tighten the steering wheel retention nut to 12 Nm (9 lb-ft). Refer to the service procedures in Section 211-04 of the appropriate Workshop Manual.

- Install a ***new*** steering column (Refer to your parts catalog to determine the specific steering column [-3524-] for the vehicle application). Use two (2) ***new*** ignition module shear bolts (YL8Z-12049-AA) and one (1) ***new*** pinch bolt (YL8Z-3R827-AA) when installing the ***new*** steering column. Refer to the service procedures in Section 211-04 of the appropriate Workshop Manual.

- Install a ***new*** steering wheel armature. Tighten the nuts to 12 Nm (9 lb-ft).
   - Install the steering wheel rear cover. Tighten the screws to 2 Nm (18 lb-in).

- Install the steering wheel. Tighten the steering wheel retention nut to 12 Nm (9 lb-ft). Refer to the service procedures in Section 211-04 of the appropriate Workshop Manual.
