CONVERTIBLE TOP—IMPROPER FIT OF CONVERTIBLE TOP BOOT	Article No. 99-22-5

FORD: 1994-2000 MUSTANG

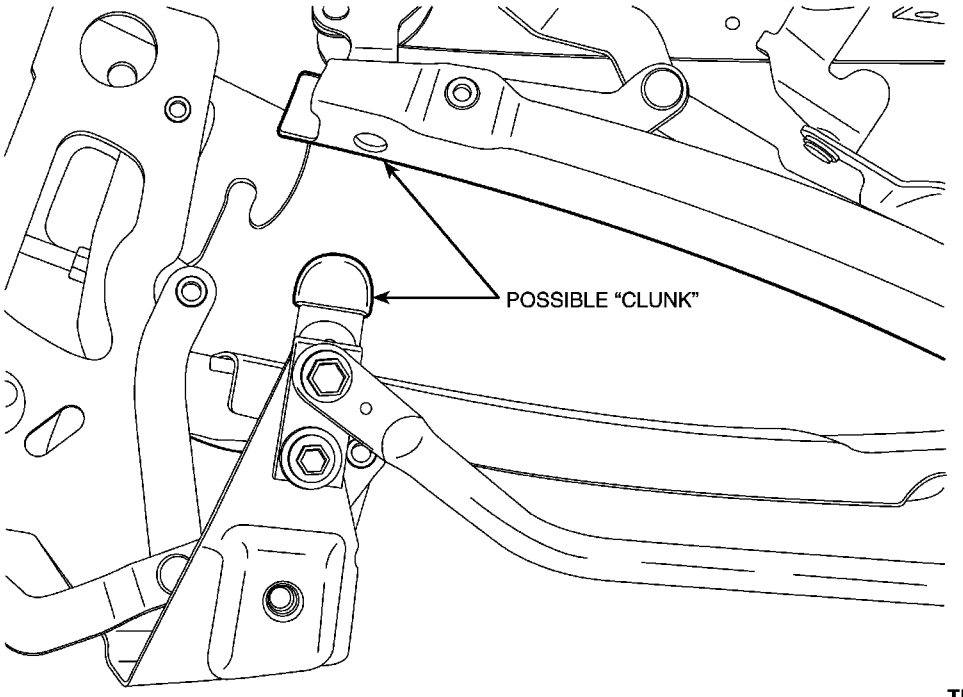
Figure 1 - Article 99-22-5

The convertible top boot may fit improperly or be difficult to install on some vehicles due to the top not folding down all the way into the well.

1. With top in the fully downstacked position, check to see if adjustment is needed to the driver side, passenger side, or both and determine the amount of adjustment needed for the top to avoid excessive contact with the boot.
2. Cycle top to closed position for easiest access to main pivot bracket and downstop bolt (Figure 1).
3. Adjust downstop bolt clockwise with a 13mm deep well socket to lower the convertible top downstack height.

NOTE
TYPICALLY ONE TO TWO TURNS WILL BE SUFFICIENT ADJUSTMENT.
