TRIM—INTERIOR REAR CORNER TRIM—MOUNTING HOLES DO NOT LINE UP CORRECTLY—POOR FIT—VEHICLES BUILT THROUGH 10/9/2000	Article No. 01-11-3

FORD: 1995-2001 RANGER

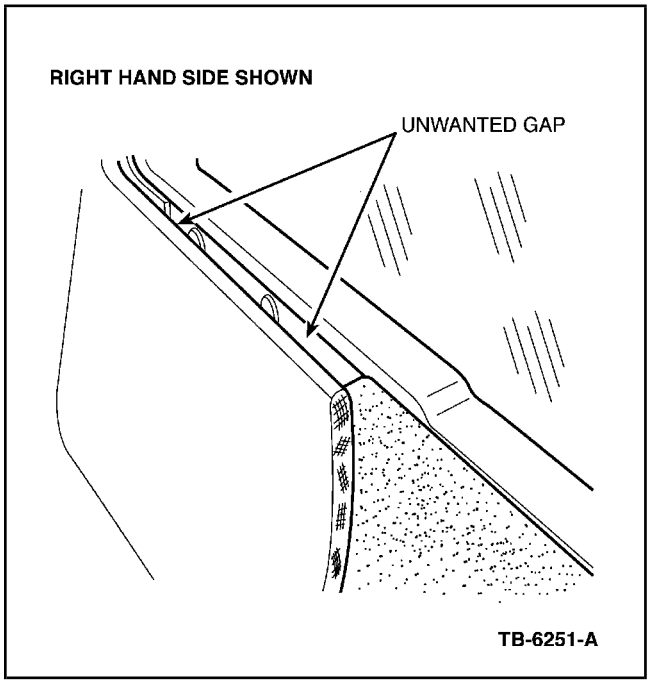
Figure 1 - Article 01-11-3

When replacing interior rear corner trim (left and/or right) the mounting holes within the sheet metal and center trim panel do not line up correctly. This may be caused by missing attachment holes in the sheet metal.

Verify that quarter trim panel(s) needs replacement due to the unwanted gap, as shown in Figure 1 or for normal rear quarter trim panel service replacement.
