BODY—WATERLEAK—COWL TO DASH WATERLEAK—WATER ACCUMULATION AND/OR LEAK AT THE DRIVER'S FLOOR PAN AREA	Article No. 02-17-4

FORD: 2002 E SERIES

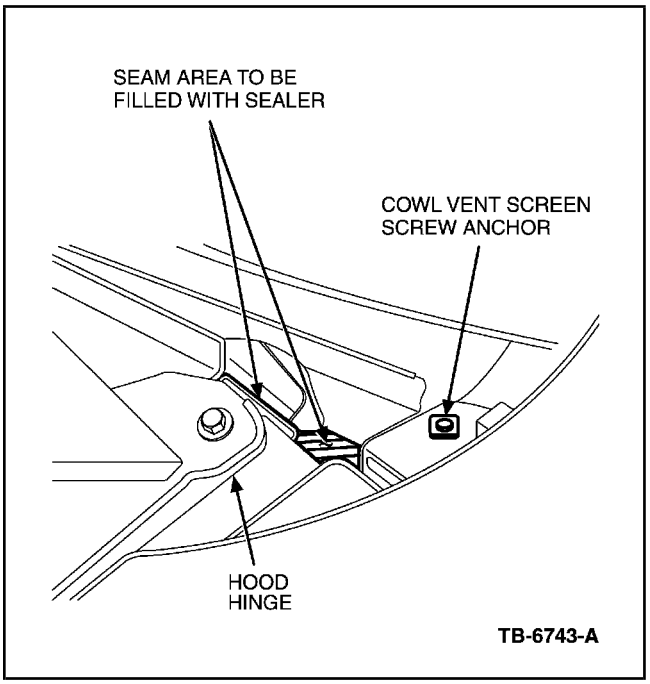
Figure 1 - Article 02-17-4

Some E-Series vehicles built between 12/01/2001 and 5/31/2002 may exhibit a water leak at the driver's side foot well. The leak may occur at the interface between the Cowl and the Dash Panel sheet metal.

6. Apply sealant by placing the tube extension adapter as far down into cowl-to-dash panel seam opening as possible, and pump sealant in along the cowl-to-dash seam until this entire area has been filled (Figure 1). Once water descending from above this seam is diverted, the leak will cease.
