NO START—VEHICLES WITH 7.3L DIESEL ENGINE	Article No. 00-5-3

FORD: 2000 F-650, F-750

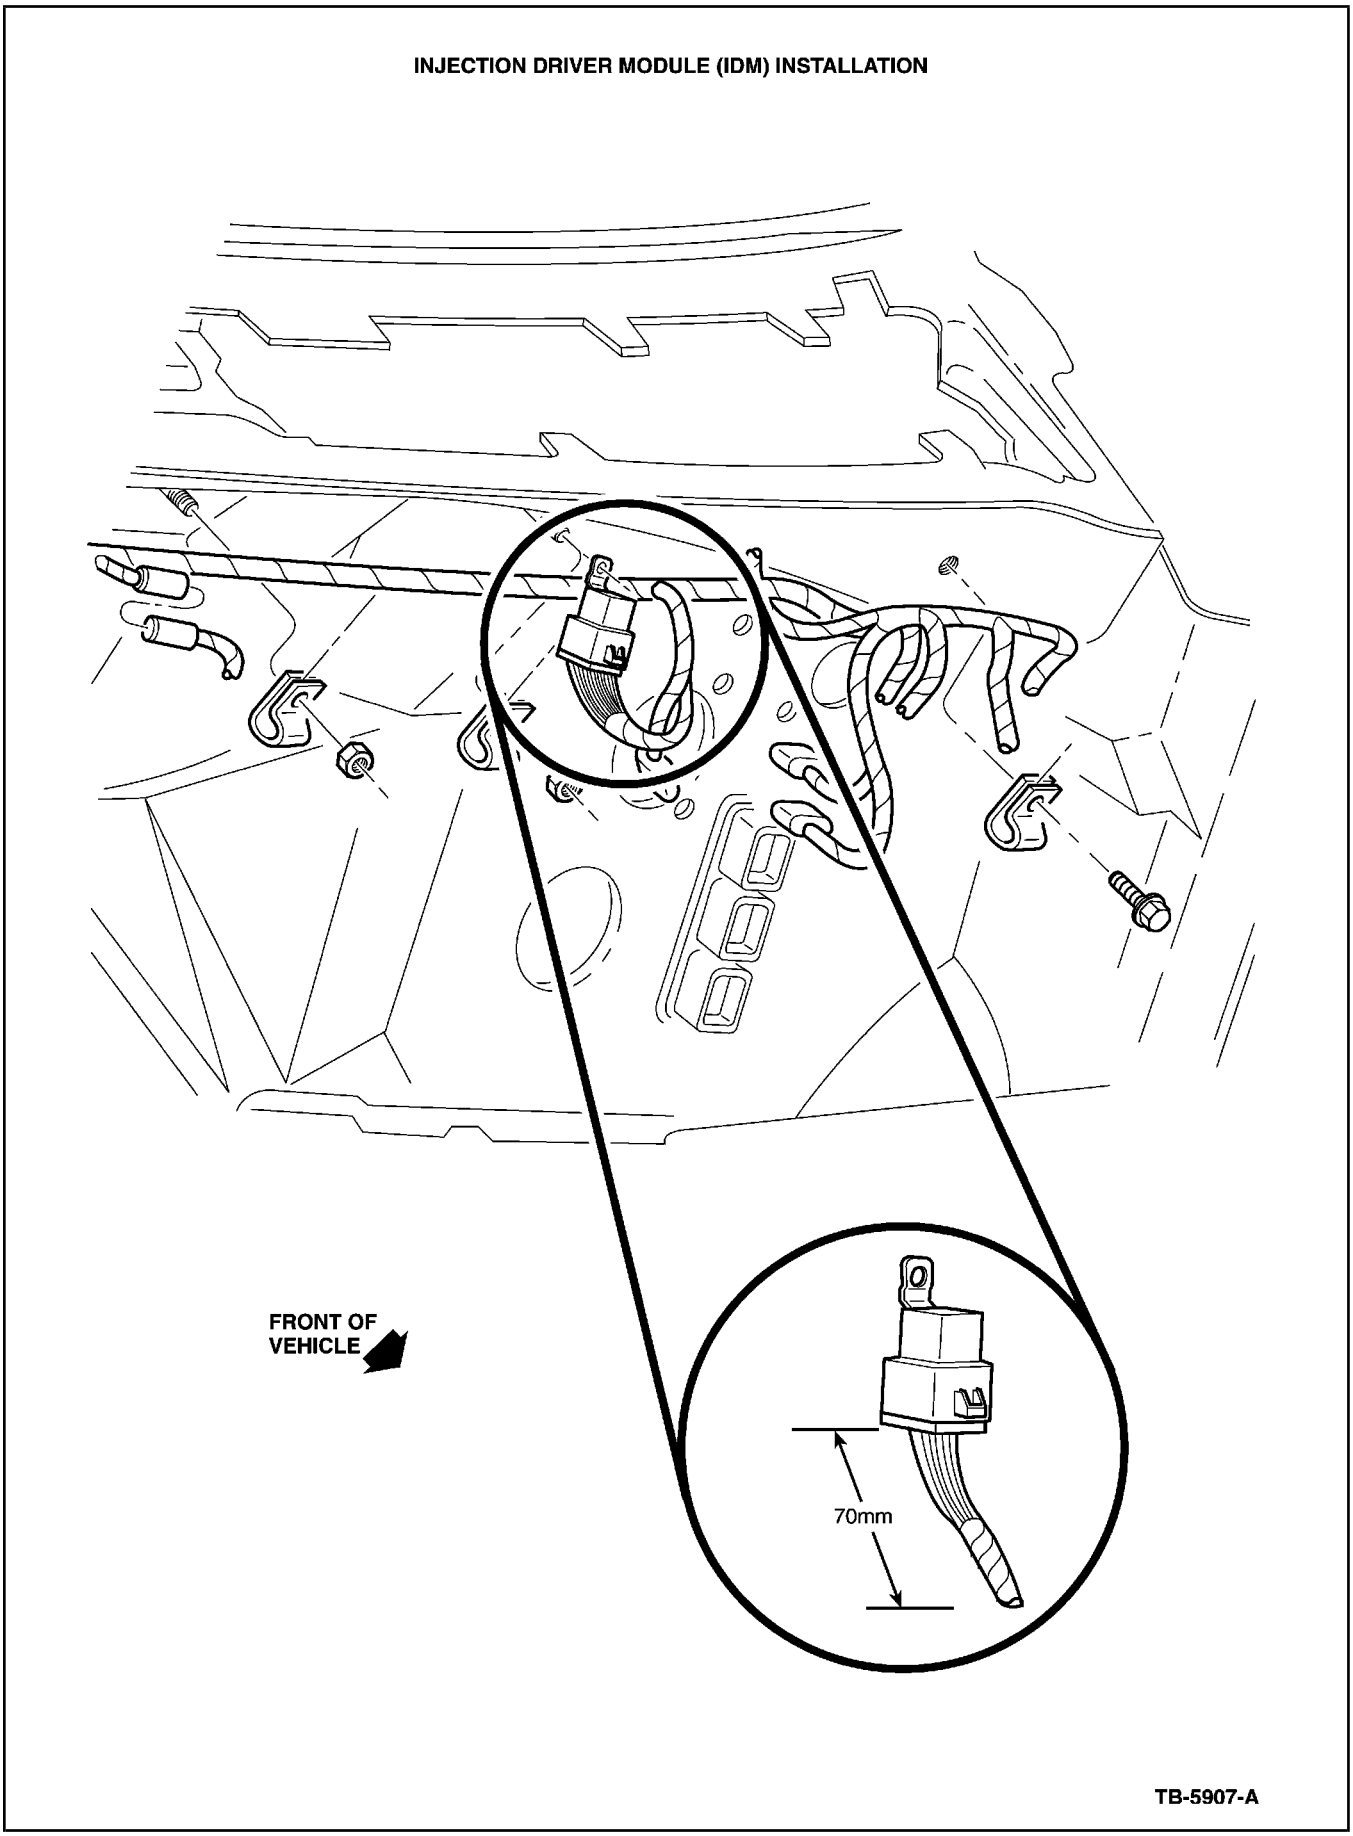
Figure 1 - Article 00-5-3

A no start condition may occur on some vehicles. This may be caused by moisture in the Injection Driver Module (IDM) relay main engine wiring harness (-12A581-), which is mounted on the bulkhead.

1. Obtain IDM Service Kit (YC3Z-14303-AA).
2. Cut the takeout to the relay about 70mm after takeout (Figure 1).
3. Shorten the pigtails to the legs that you need and splice to the same colored wire. Refer to TSB 99-22-2 for wire harness terminal repair and wire splice procedure.
4. Remove the IDM relay and install revised IDM relay. If the IDM retainer is broken, tape the new relay on the harness.
