STEERING—STEERING COLUMN POP/CLICK NOISE REPAIR PROCEDURE	Article No. 02-21-3

FORD: 2002 THUNDERBIRD

LINCOLN: 2001-2002 LS

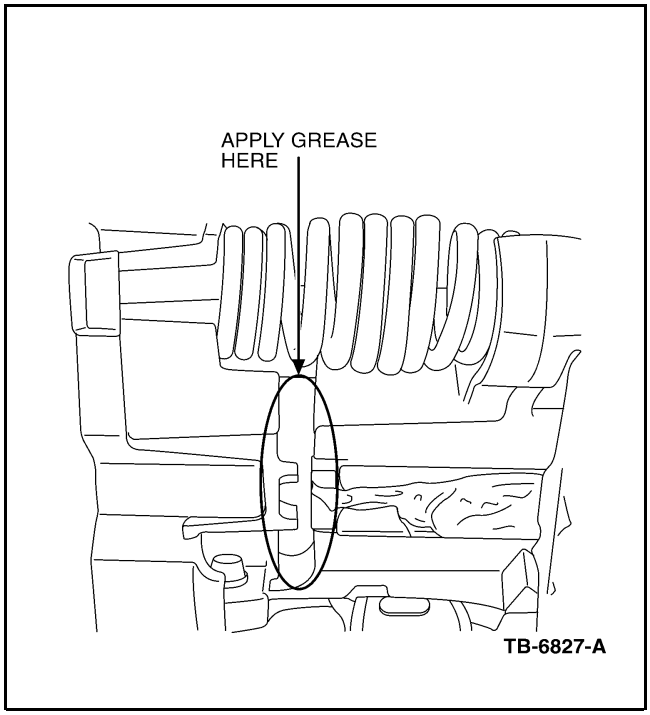
Figure 2 - Article 02-21-3

Some vehicles may exhibit a pop or click type noise from the steering column while turning the steering wheel. This may be caused by a lack of lubrication at the interface of the Upper Tilt Shaft to Upper Tilt Shaft Bearing surface in the steering column.

7. Using a flat screwdriver, carefully pry the tolerance ring up the shaft and remove.
8. Push the shaft forward positioning it so that the tapered surface of the shaft (where it contacts the upper bearing inner race) is clearly visible between the steering column upper bearing housing and inner housing (Figures 2 and 3).

MAKE CERTAIN THE LUBRICANT COVERS ENTIRE SURFACE OF THE SHAFT TAPER WHERE IT ENGAGES THE BEARING INNER RACE. REFER TO FIGURE 2.
