• BODY—“SQUEAK” OR BIND FROM TAILGATE • NOISE—“SQUEAK” OR BIND FROM TAILGATE	Article No. 02-3-5

FORD: 1997-1998 F SUPER DUTY
1997-2002 F-150, RANGER
1999-2002 SUPER DUTY F SERIES
2001-2002 EXPLORER SPORT TRAC

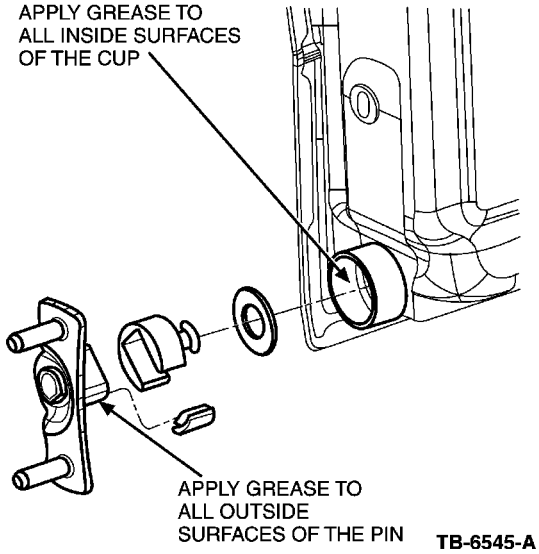
Figure 1 - Article 02-3-5

Some vehicles may exhibit a “Squeak” or Bind condition of the Tailgate. This may be caused by the grease on the tailgate hinges that may wash out prematurely causing a squeak or binding condition.

1. Remove tail gate from the vehicle.
2. Remove plastic inserts from tail gate hinge cups.
3. Clean inside of hinge cups.
4. Apply grease (use only XG-3), to all inside surfaces of right and left side hinge cups and right and left side body side pins (Figure 1) and re-install plastic inserts into tail gate.
5. Reinstall the tail gate.
