TRIM—HEADLINER SAG/LOOSE AT REAR QUARTER GLASS NEAR C OR D PILLAR AREA	Article No. 01-23-7

FORD: 2001 ESCAPE

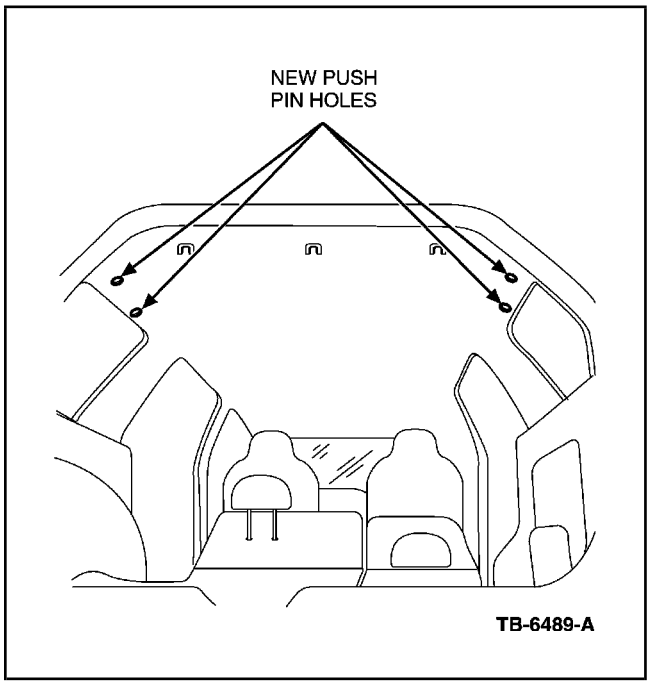
Figure 1 - Article 01-23-7

Some vehicles built prior to 7/31/2001 may exhibit a headliner sag/loose condition at rear quarter glass area near C/D pillar. This may be caused by a process change at the headliner manufacturing facility.

1. Locate new push-pin holes (See Figure 1 for example locations).
2. Cut template along the curves printed on both sides of template.
3. Make two holes on template along the printed circles.
4. Align template with glass and C-pillar or D-pillar as noted on template. Make sure arrow points to front of the vehicle. Use template for locating proper push-pin spacing (Figure 2).
5. Fit the D-pillar side edge as noted on template and the D-pillar to locate the new push-pin positions between D-pillar and C-pillar (Figure 2).
6. Mark both left-hand side and right-hand side new pin position holes as noted on template. Make sure arrow points to front of the vehicle.
