INTAKE MANIFOLD INSPECTION/REPLACEMENT

AFFECTED VEHICLES: **1996-2001 MODEL YEAR CROWN VICTORIA POLICE**
1998-2001 MODEL YEAR CROWN VICTORIA TAXI
1998-2001 MODEL YEAR TOWN CAR LIMOUSINE/LIVERY

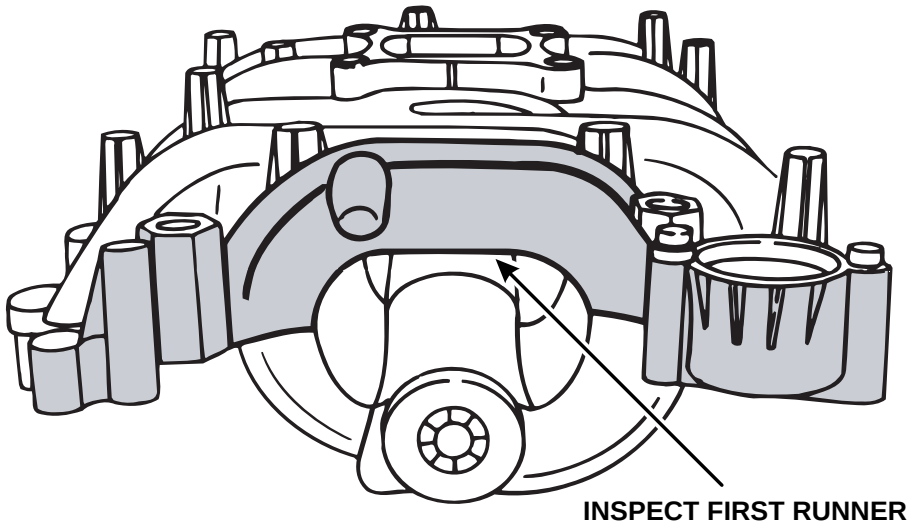
FIGURE 1

Inspect the coolant crossover area of the intake manifold as shown in Figure 1 for engine coolant seepage.

ALTERNATOR REMOVED FOR CLARITY

- If seepage **IS** present, the intake manifold **MUST** be replaced. Refer to the appropriate Workshop Manual section 03-01 for 1996 through 1998 model year vehicles and section 303-01 for 1999 through 2001 model year vehicles for replacement procedures for intake manifold.
   - If seepage is **NOT** present, no service action is required.
