- **BODY—LEFT FRONT DOOR WILL NOT STAY OPEN—LOOSE DOOR CHECK STRAP—VEHICLES PRODUCED AT WAYNE ASSEMBLY PLANT BETWEEN 5/22/2002 AND 5/24/2002 ONLY**
- **NOISE—RATTLE NOISE FROM LEFT FRONT DOOR AREA—LOOSE DOOR CHECK STRAP—VEHICLES PRODUCED AT WAYNE ASSEMBLY PLANT BETWEEN 5/22/2002 AND 5/24/2002 ONLY**

Article No. 02-25-10

FORD: 2002 FOCUS

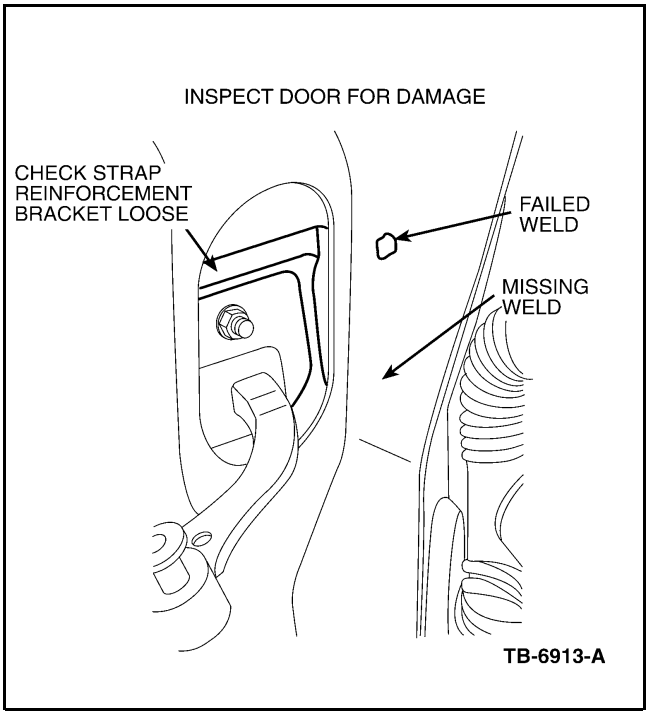
Figure 1 - Article 02-25-10

1. Inspect left front door area around door check strap for damage (Figure 1):
   a. Verify if check strap reinforcement bracket is loose.
   b. Remove door trim panel.

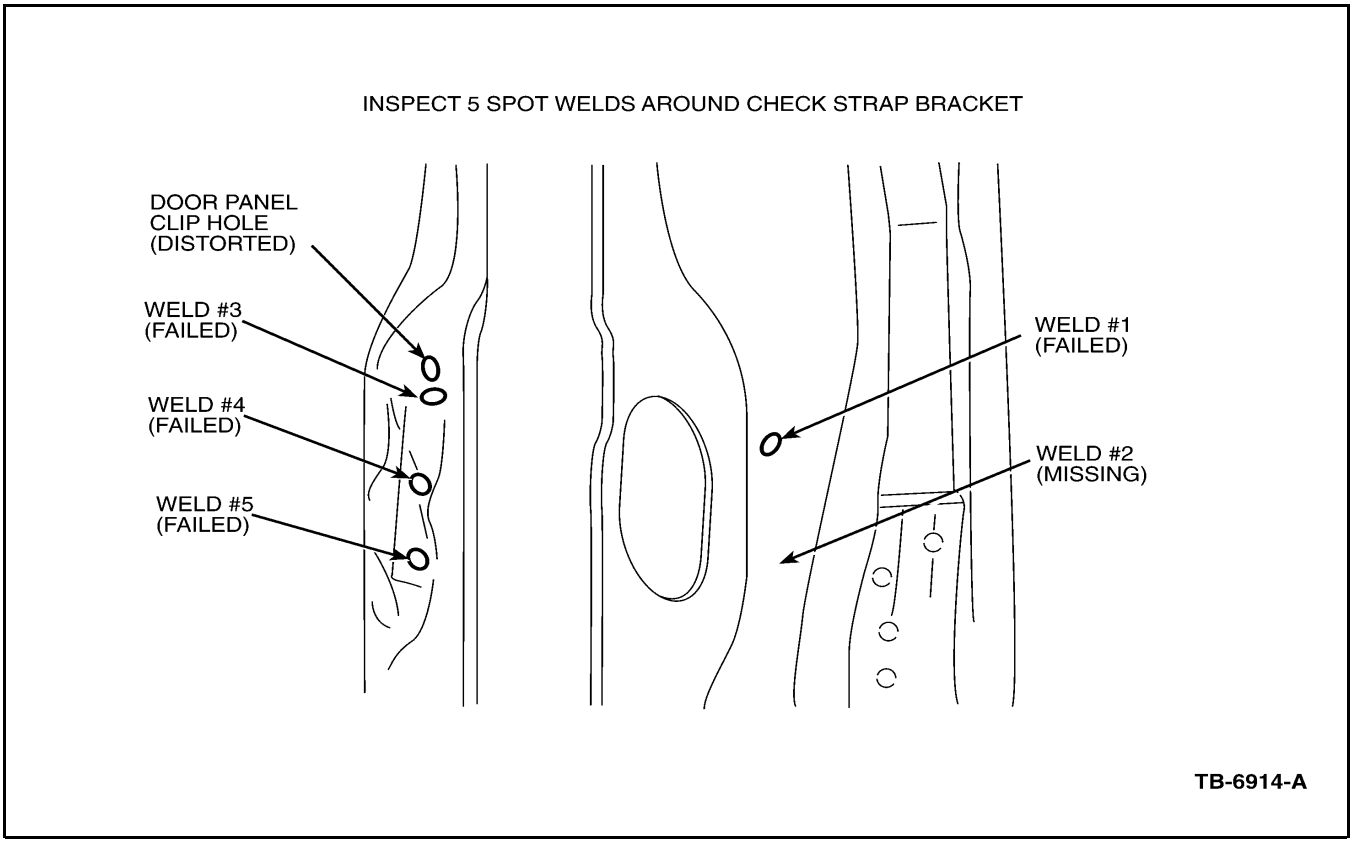
Figure 2 - Article 02-25-10

c. Inspect 5 spot welds between check Strap Reinforcement Bracket and door inner sheet metal (Figure 2).
   d. Inspect for distortion around door inner sheet metal near check Strap Reinforcement Bracket.
