TRANSAXLE—CD4E—NO FORWARD ENGAGEMENT—FORWARD CLUTCH CYLINDER SNAP RING POSITION—SERVICE TIP	Article No. 00-18-2

FORD: 1994-1997 PROBE
1994-2000 CONTOUR
2001 ESCAPE

MERCURY: 1994-2000 MYSTIQUE
1999-2001 COUGAR

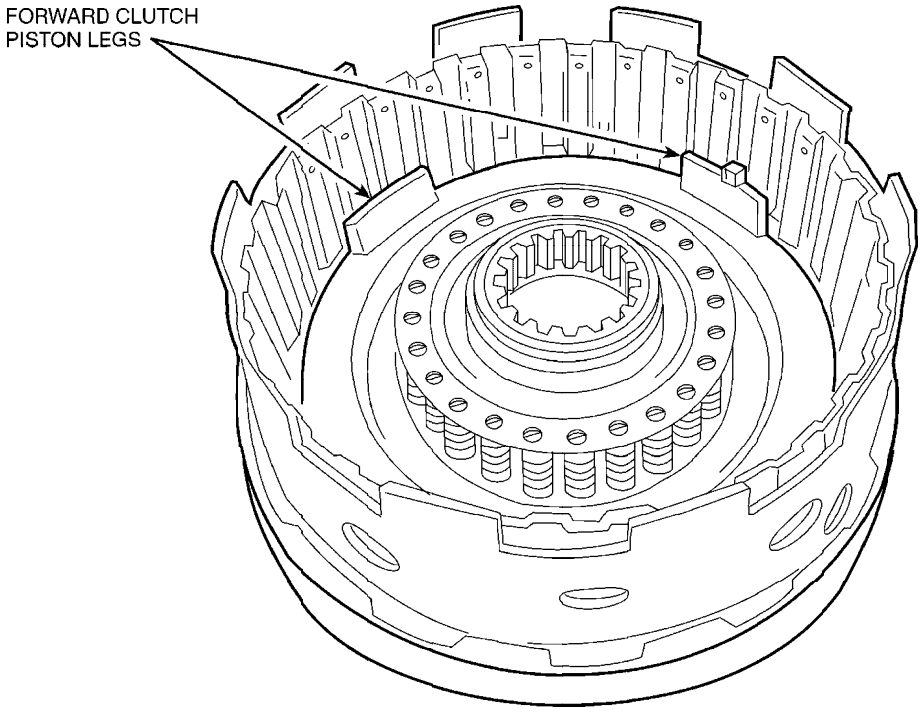
Figure 1 - Article 00-18-2

1. Prior to installing the forward and coast clutch plates into the cylinder, note the location of the four (4) forward piston legs (Figure 1).
2. Mark the top of the cylinder with a felt tip marker midway between any two adjacent legs (i.e., 45 degrees or 4 external spline teeth from the center of any leg) (Figure 2).

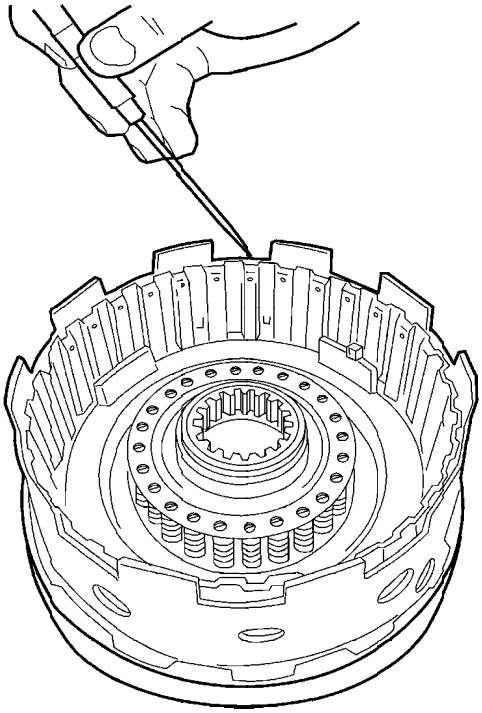
Figure 3 - Article 00-18-2

AFTER INSTALLING CLUTCH PLATES, POSITION ENDS OF SNAP RING AT MARK ON CYLINDER

3. Following the Service or Workshop Manual procedure, install the clutch plates.
4. Position the ends of the snap ring such that the gap is aligned with the mark on the top of the cylinder (the 45 degree mark) (Figure 3).
5. Perform end clearance check as required.
