SUBJECT: *Safety Recall 01S21 Supplement #1*

REFERENCE: DEMONSTRATION / DELIVERY HOLD: Safety Recall 01S21: Certain 2001 Model Year Crown Victoria, Excursion, Expedition, F-150, F-250 through F-550, Grand Marquis, Navigator, Ranger, Town Car, and Windstar vehicles - Seat Belt Buckle Retention

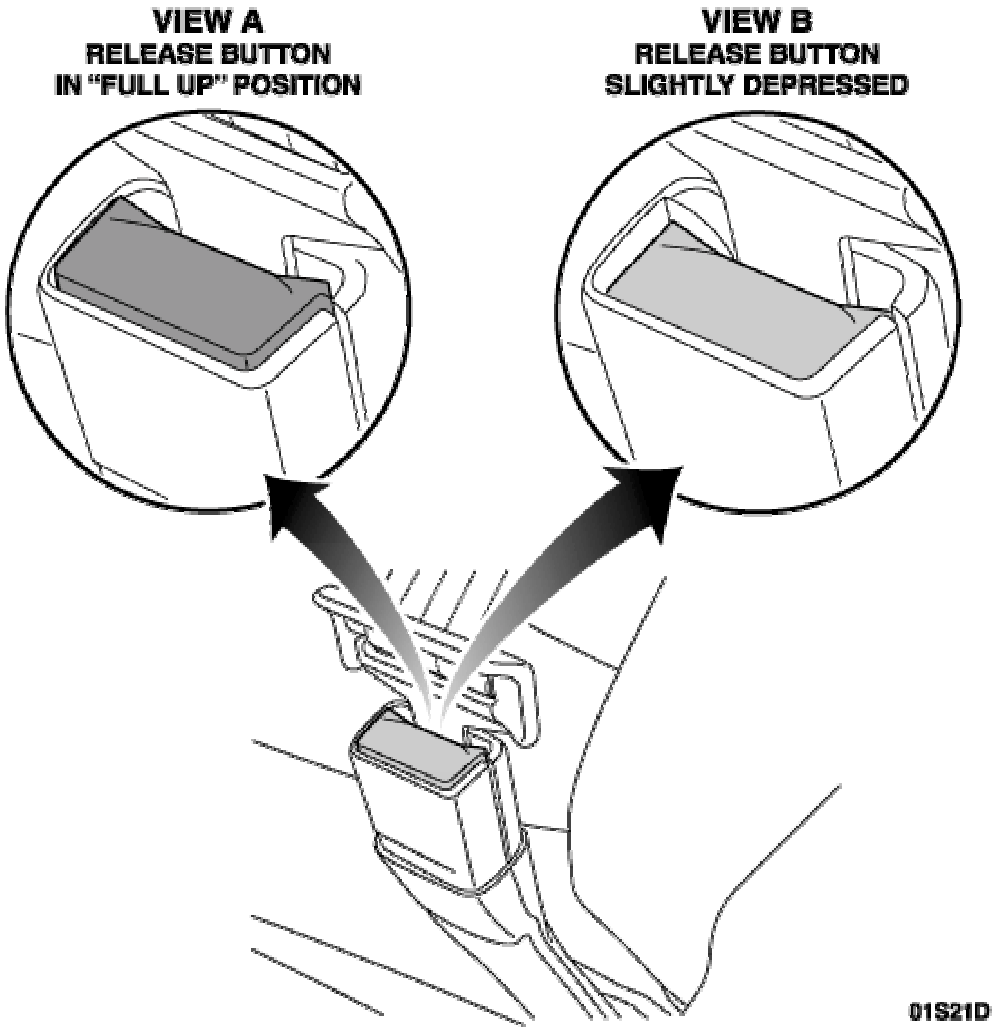
The illustration below shows the red seat belt buckle release button in both the **"full up",** or properly latched position (View A) and in a "**slightly depressed**" position (View B). Notice: When properly latched, the red release button will return to the position it was in before the tongue was inserted into the seat belt buckle.

If your buckle release button looks like that shown in View B, the buckle is only partially latched. Remove the tongue from the buckle by pressing the red release button. After removal, reinsert the tongue quickly and firmly into the buckle. Be sure that the red release button is in the position shown in View A ("full up" position) after insertion.
