• **BODY—#3 BODY MOUNT REINFORCEMENT PLATE CRACK—VEHICLES PRODUCED 8/30/2000 THROUGH 11/30/2000 ONLY** • **NOISE—"CREAKING" NOISE WHILE TURNING OR OVER BUMPS—#3 BODY MOUNT REINFORCEMENT PLATE CRACK—VEHICLES PRODUCED 8/30/2000 THROUGH 11/30/2000 ONLY**	**Article No. 01-22-5**

FORD: 2001 EXPLORER SPORT TRAC

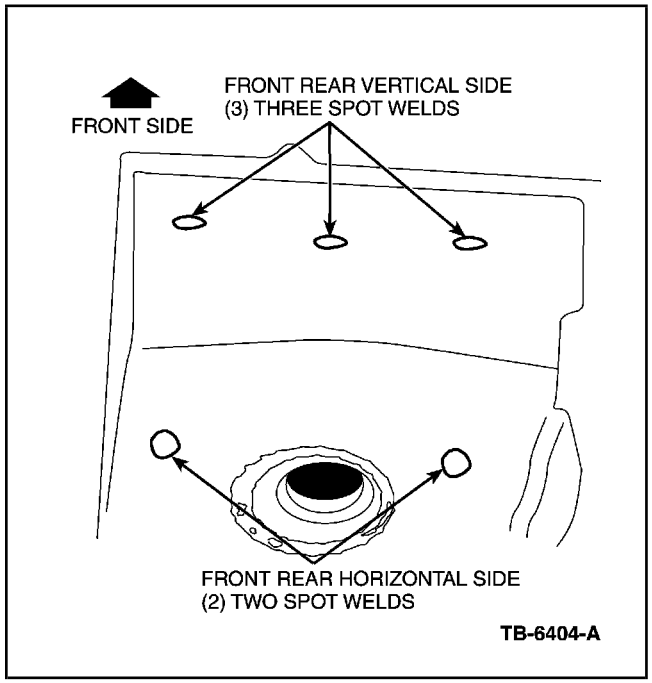
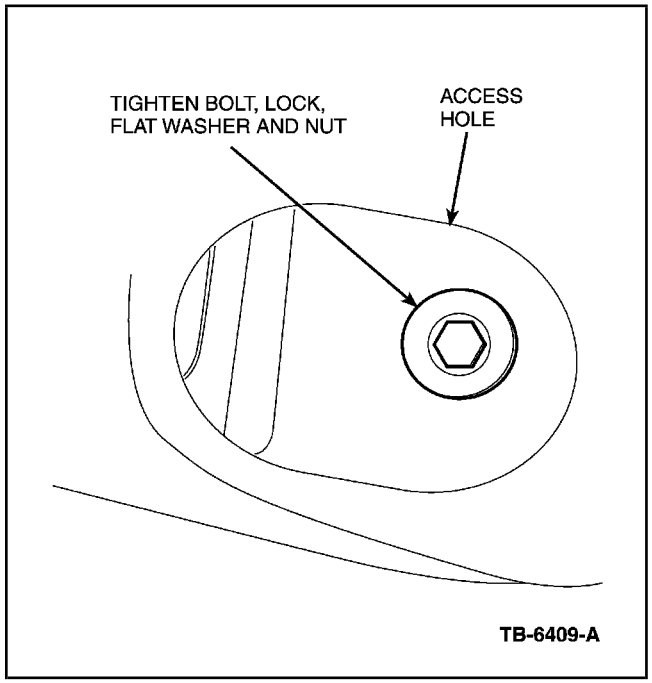
Figure 1 - Article 01-22-5

Some vehicles may exhibit a metallic creaking noise while driving on rough roads, making turns, or driving over speed bumps. The noise may be originating from either the right or left hand side of the passenger compartment under the seat. This may be caused by cracks at the #3 body mount reinforcement metal.

1. Lower rear seats and open back panel compartments. Remove (2) rubber body plugs to perform the inspection procedure.
2. Visually inspect the underbody rear body mount #3 area. Inspect the sheet metal on both right and left sides above the body rubber mount bushing, and at the area around the base of the upper washer for small hairline cracks. Cracks in this area may be the cause of the creaking noise (Figure 1).
3. Inspect the body welds above the rear RH and LH body mounts and look for any signs of stress cracks in this location (Figure 2).
   a. If cracks are found or if reinforcement is separated, continue to Step 4.
   b. If no cracks are found, inspect reinforcement from inside the vehicle to confirm that it is secured to the underbody cross member.
4. Remove the rear body mount bolts only. Keep the body mounts in place.
