ELECTRICAL—AM BAND RADIO PERFORMANCE—MULTIPLEX COMMUNICATION NETWORK INTERFERENCE	Article No. 02-10-2

FORD: 2002 THUNDERBIRD

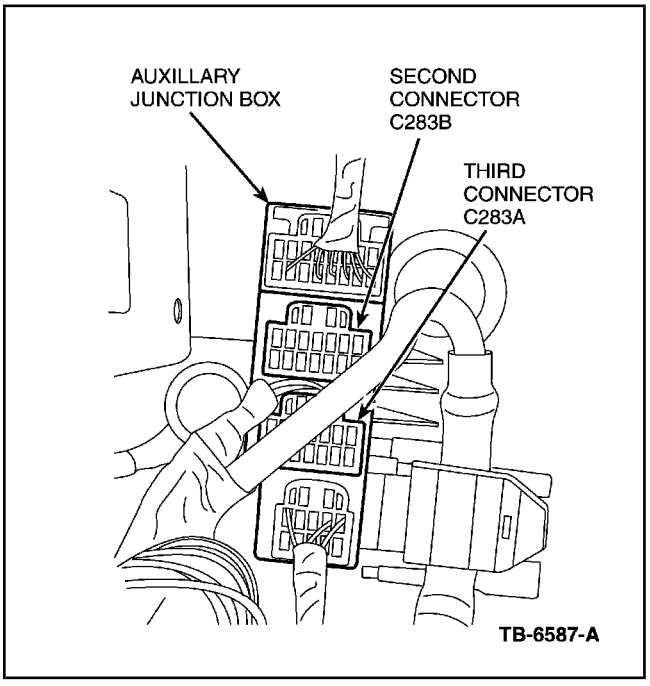
Figure 1 - Article 02-10-2

10. Unpack and lay out the Service Wiring Harness 1W6Z-14588-AA. The front of the harness is the end with terminals bunched tightly together.
11. Locate and unplug the 2nd (C283b) and 3rd (C283a) connectors at the Auxiliary Junction Box. These connectors are located along the left lower section of the interior bulkhead (Figure 1).

12. Using a small-standard flat blade screwdriver, gently remove the secondary locks from 2 (two) connectors by first lifting the lock from the center/top until it is evenly raised slightly off the connector. Finish by lifting up on the side of the lock and remove from the connector.

13. To remove the wire and terminal, insert a flat blade mini-screwdriver into the face of the connector and gently lift the locking tab inside the desired cavity. Pull out the wire and terminal from rear of the connector. For detailed connector views, refer to Wiring Diagrams Manual, Section 150. The following are the correct connector/circuit locations. Immediately insert the matching wire from the service kit to avoid confusion:

a. **C283a (blue)** - Ckt 4-EG13 GY/OR, Cavity 8 - replace with GY/OR in Service Kit
    b. **C283a (blue)** - Ckt 5-EG13 BU/BK, Cavity 4 - replace with BU/BK in Service Kit

c. **C283b (grey)** - Ckt 4-EG12 GY/WH, Cavity 16 - replace with GY/WH in Service Kit
    d. **C283b (grey)** - Ckt 5-EG12 BU/OR, Cavity 12 - replace with BU/OR in Service Kit

14. Reinstall the secondary locks in each connector and reconnect C283a and C283B to their correct locations at the Auxiliary Junction Box.
15. Use electrical tape to completely cover each of the 4 (four) removed terminals.
