FRONT SUSPENSION MOUNTING BRACKET BOLTS

AFFECTED VEHICLES: **CERTAIN 2001 MODEL YEAR U.S. POSTAL STRIPPED CHASSIS**

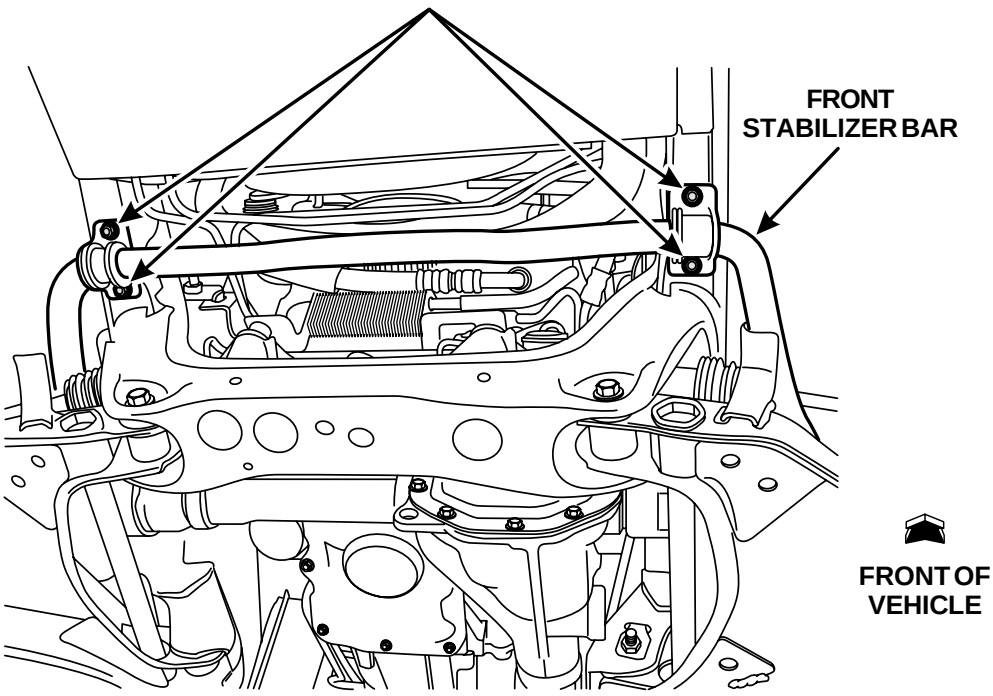
FIGURE 1

The left and right hand front stabilizer bar mounting bracket bolts on the affected vehicles must be tightened to specification.

NOTE: If any loose bolts are found, inspect the bolt threads, stabilizer bar bushings and mounting brackets for damage and replace if necessary.

1. Raise the vehicle on a hoist.
2. Tighten all four (4) front stabilizer bar mounting bracket bolts to 40 Nm (30 lb-ft). See Figure 1.
3. Lower the vehicle.
