POWER DOOR LOCKS—SELF-ACTIVATING OR CYCLING—VEHICLES BUILT FROM 9/26/1998 THROUGH 9/5/2001	Article No. 02-4-3

MERCURY: 1999-2002 VILLAGER

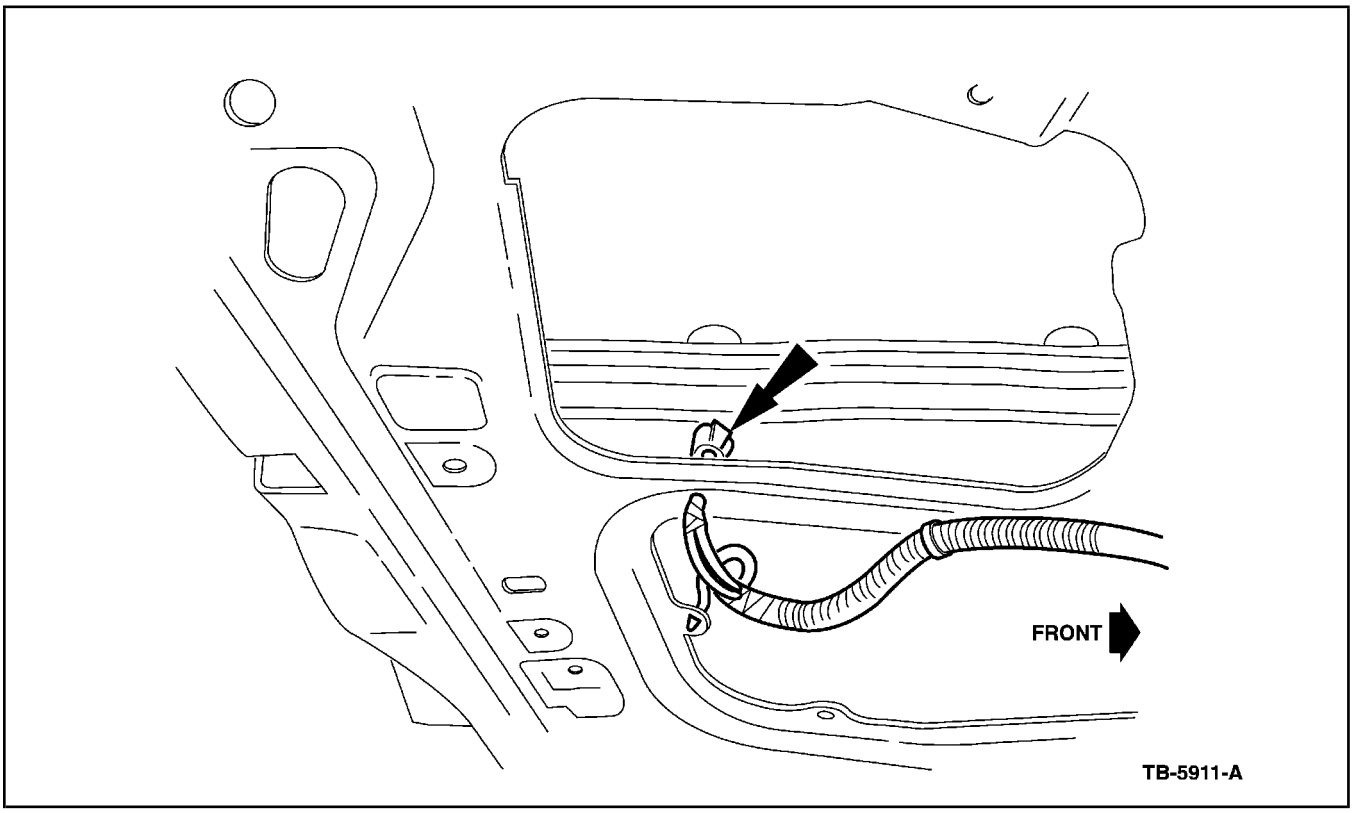
Figure 4 - Article 02-4-3

9. If vehicle is equipped with optional anti-theft OR vehicle build date is after 4/1/1999, proceed to Step 11. If vehicle is NOT equipped with anti-theft AND build date is 4/1/1999 or earlier, check for a possible open 4-pin gray harness connector with three (3) wires (RD, RD/BK, and BK) inside the front door (Figure 4).

10. If found, remove and discard the connector by cutting the wires, then seal the exposed ends with heat-shrink tubing.
11. If the vehicle WAS built between 10/30/00 and 9/5/01, inspect inside the door for the wiring harness contacting the door check strap while opening and closing the door (Figure 5). If wiring damage is found, repair as necessary. If the vehicle WAS NOT built between 10/30/00 and 9/5/01, proceed to Step 13.

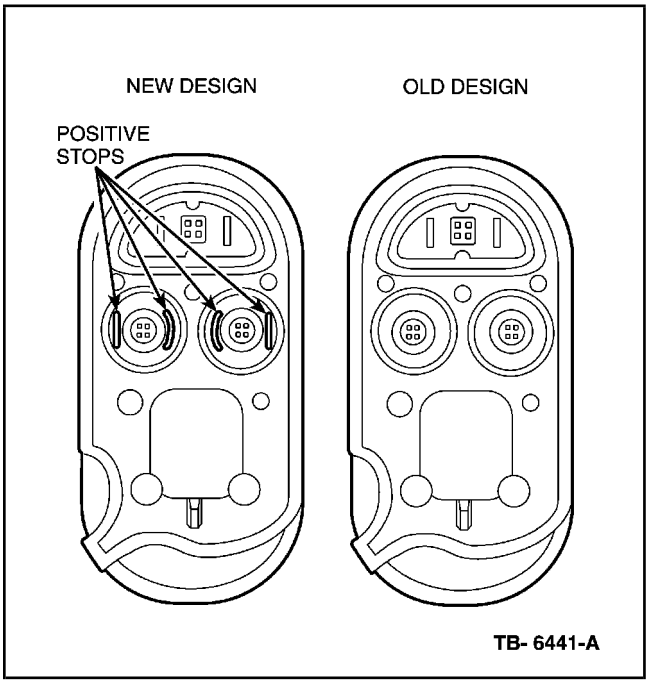
Figure 7 - Article 02-4-3

15. If the vehicle was built between 9/28/98 and 4/1/01, use a coin or comparable tool to open the key fobs. Inspect the back side of the unlock and panic buttons for the "positive stops" (Figure 7). If the "positive stops" are not present as shown for the new style key fob in Figure 7, replace the key fobs.
