SUSPENSION—CNG EXTENDED RANGE VEHICLES SITTING LOW IN REAR	Article No. 02-18-6

FORD: 1998-2002 CROWN VICTORIA

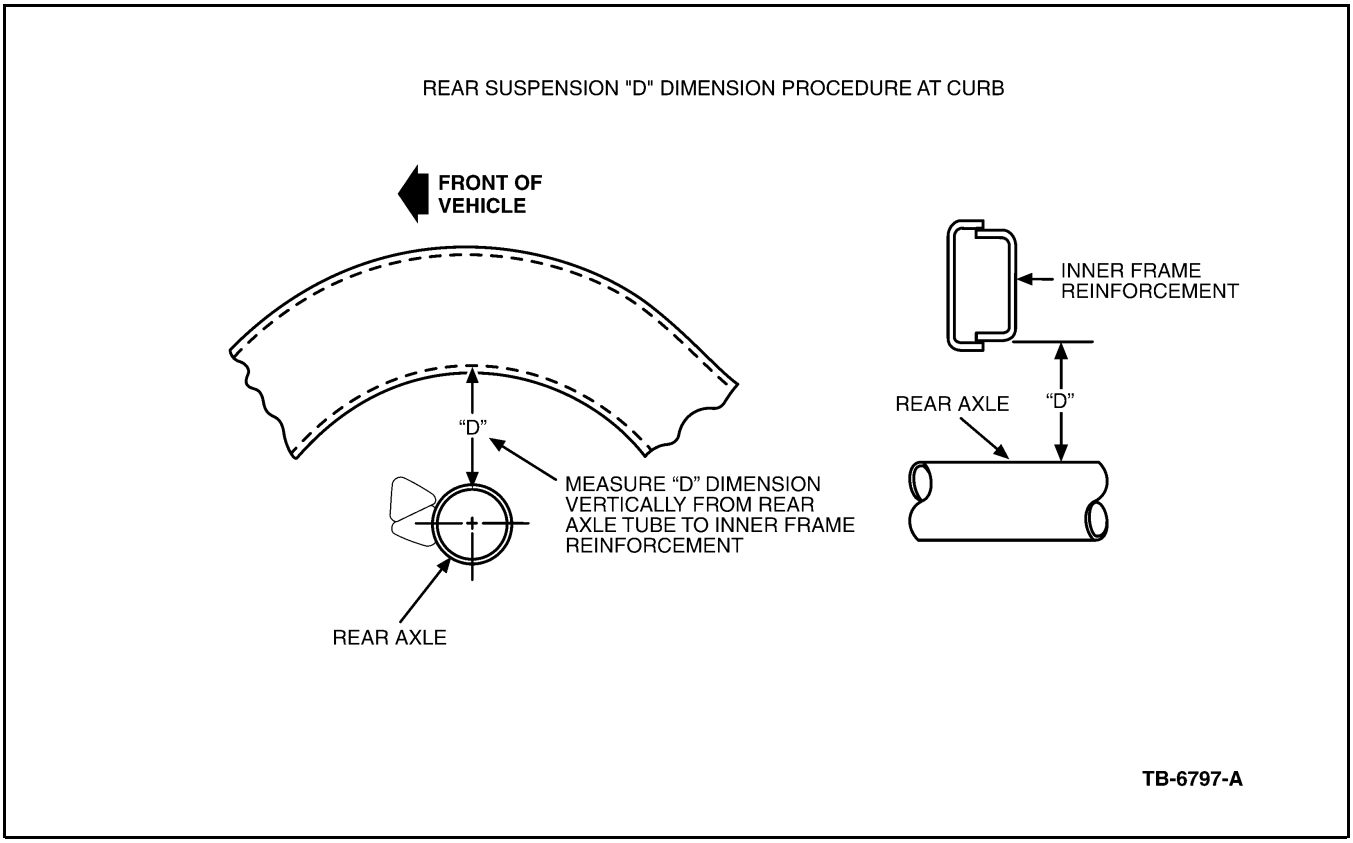
Figure 1 - Article 02-18-6

a. Measure from the top of the axle tube to the underside of the frame (Figure 1).

b. The rear ride height measurement should be 5.2 inches (+/- .3) or 137 mm to 153mm.

c. If below specification, Replace rear springs with updated part D9AZ-5560-AE.
