RADIO—REPLACEMENT SPEAKER HAS THREE MOUNTING HOLES INSTEAD OF FOUR—INSTALLATION TIPS

Article No. 02-20-1

FORD: 1995-2000 CONTOUR

MERCURY: 1995-2000 MYSTIQUE

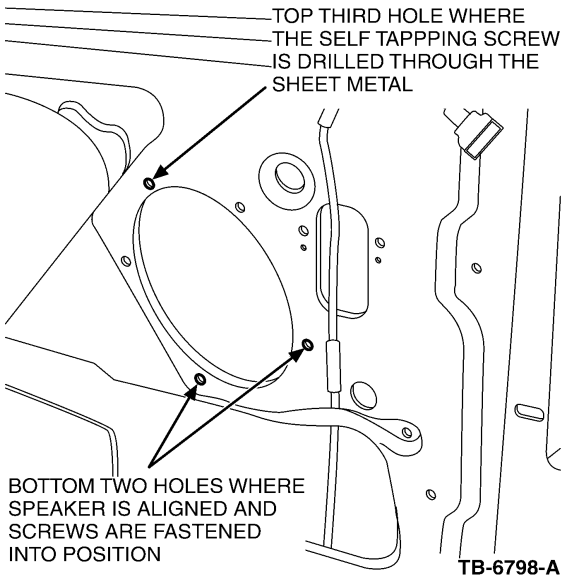
Figure 1 - Article 02-20-1

When necessary to replace a door speaker, the new replacement speaker will have three mounting holes instead of four. The four hole speaker is no longer available.

When replacing a door speaker, 2 of the original mounting points will align with the new speaker and 1 additional hole will need to be made to mount the new speaker to the door.

1. Place the window in the up position.
2. Align the two bottom holes on the speaker with the 2 bottom original holes on the inner door panel (Figure 1).
3. Fasten the bottom two screws into position (Figure 1).
4. Using 1 of the original screws, attach the third mounting screw into the top locator hole using a power screw gun. The screw is a metal, self-tapping screw and will cut through the inner door panel sheet metal (Figure 1).
5. Re-assemble the door trim
