CLUTCH—CLUTCH PEDAL GOES TO FLOOR— CLUTCH WILL NOT FULLY DISENGAGE	Article No. 02-6-1

FORD: 1999-2002 F-650, F-750

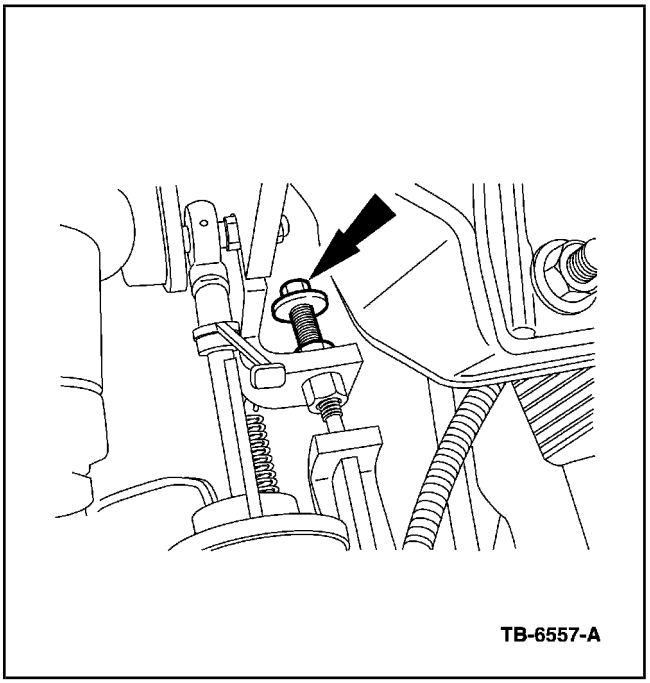
Figure 1 - Article 02-6-1

Some vehicles may exhibit a clutch that does not disengage, and/or clutch pedal sits on floor. This may be caused by the Clutch Pedal Return Spring and the Clutch Pedal adjustment.

Inspect hydraulic clutch system for any hydraulic fluid leaks, and repair leaks prior to proceeding. If no leaks are found, then obtain 0.020 inch feeler gauge. Also obtain spring 2C4Z-7523-AA. Remove old clutch lever return spring YC3Z-7523-AA and measure free play gap between clutch pedal adjustment screw, and screw stop (gap when fork lever touches the throwout bearing). If this gap is 0.530 +/- 0.030 inch then install clutch pedal return spring 2C4Z-7523-AA. If this gap is not within specification, loosen nut and back out adjustment screw until it measures 0.530 +/- 0.030 inch (Figure. 1). Install clutch pedal return spring 2C4Z-7523-AA.
