TRANSMISSION—T-45 MANUAL TRANSMISSION—STUCK IN REVERSE—DIFFICULT TO SHIFT INTO REVERSE—POPS OUT OF REVERSE	Article No. 01-23-5

FORD: 1996-2001 MUSTANG

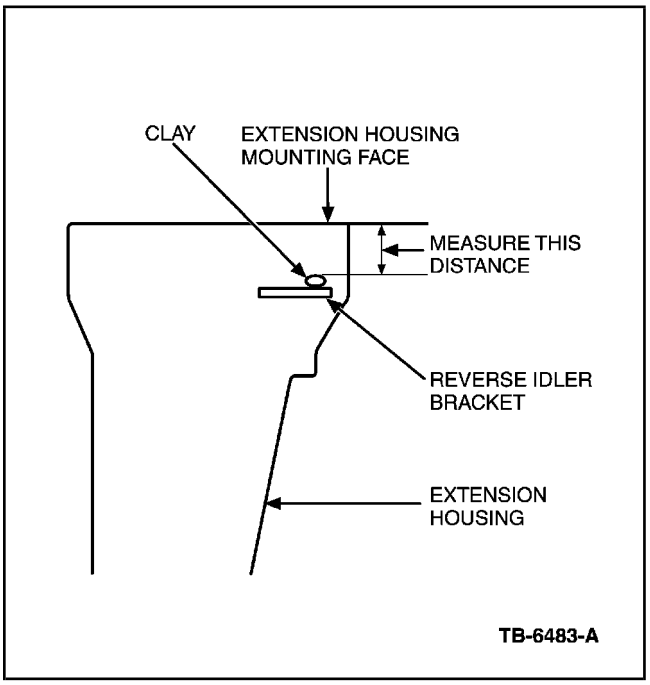
Figure 1 - Article 01-23-5

1. While viewing the extension housing from the front, place a small amount of standard modeling clay on the reverse idler bracket (7723) near the 5th/reverse shift rail support hole (near the exterior wall of the housing Figure 1).
