NOISE—"BUZZ" COMING FROM CENTER OR RIGHT SIDE OF INSTRUMENT PANEL—HEARD AT IDLE OR LOW SPEED DRIVING	Article No. 01-4-10

FORD: 2001 EXPLORER

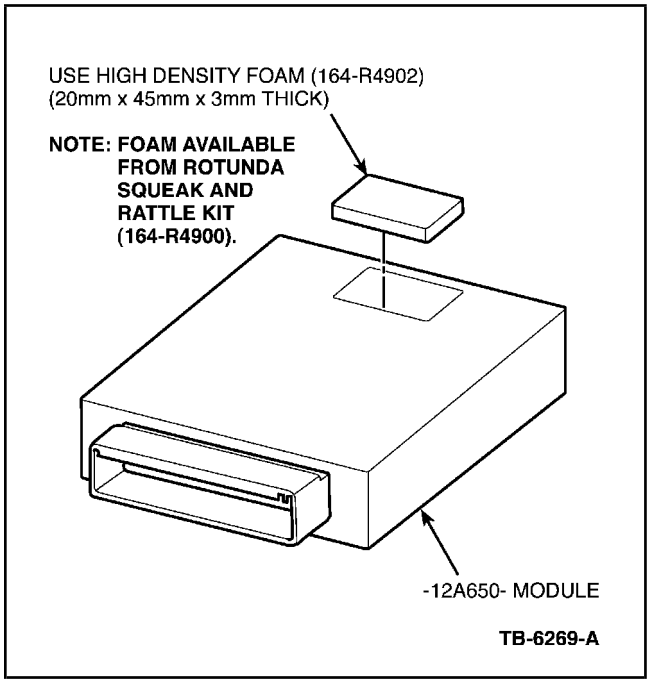
Figure 1 - Article 01-4-10

Some Sport and Sport Trac vehicles built between 7/1/2000 and 2/28/2001 may exhibit a "buzz" coming from the center or right side of the instrument panel at idle and/or low speed driving with rpm range between base idle and 1800 rpm. This may be caused by the Powertrain Control Module (PCM) resonating against the heat shield that is located inside the PCM.

1. Remove the PCM from the vehicle. Refer to the 2001 Explorer Workshop Manual, Section 303-14 for removal procedure.
2. Cut a piece of Urethane Tape (hard foam), Rotunda part number 164-R4902, to the following dimensions: 20mm width, 3mm thickness, and 45mm length. The urethane tape is located in the Rotunda Squeak and Rattle Kit, part number 164-R4900.
3. Lay the PCM flat on a table. After removing the adhesive backing, place the foam tape on the top surface of the module at the rear center of the module. This will dampen the buzz noise from the PCM outer case. (Figure 1).
4. Reinstall the PCM. Refer to the Workshop Manual, Section 303-14 for installation procedure.
5. Test drive vehicle to verify that the noise is corrected.
