ELECTRICAL—AIRBAG DIAGNOSTIC TROUBLE CODES (DTC) B2290 AND/OR B2295—DIAGNOSTIC SERVICE TIPS	Article No. 02-21-7

FORD: 2003 CROWN VICTORIA

MERCURY: 2003 GRAND MARQUIS

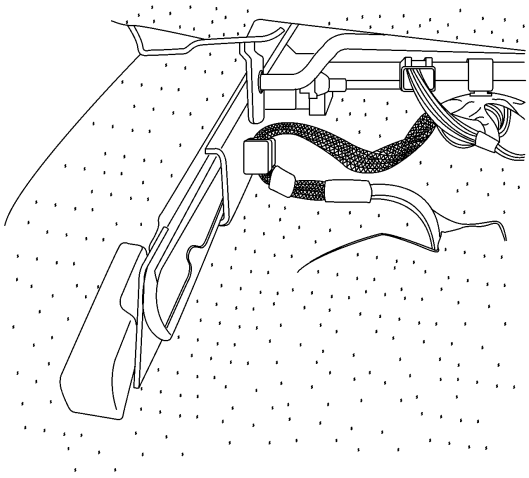
Figure 1 - Article 02-21-7

- **14A005 wire harness routing under the seat - Figure 1.** Vehicles built before 08/26/2002: The 14A005 wire harness may become trapped under the seat track due to excess wire length. Later vehicles have the wire harness shortened by 4 inches (100 mm) to reduce the possibility of becoming trapped during production.

REAR VIEW OF FRONT SEAT TRACK

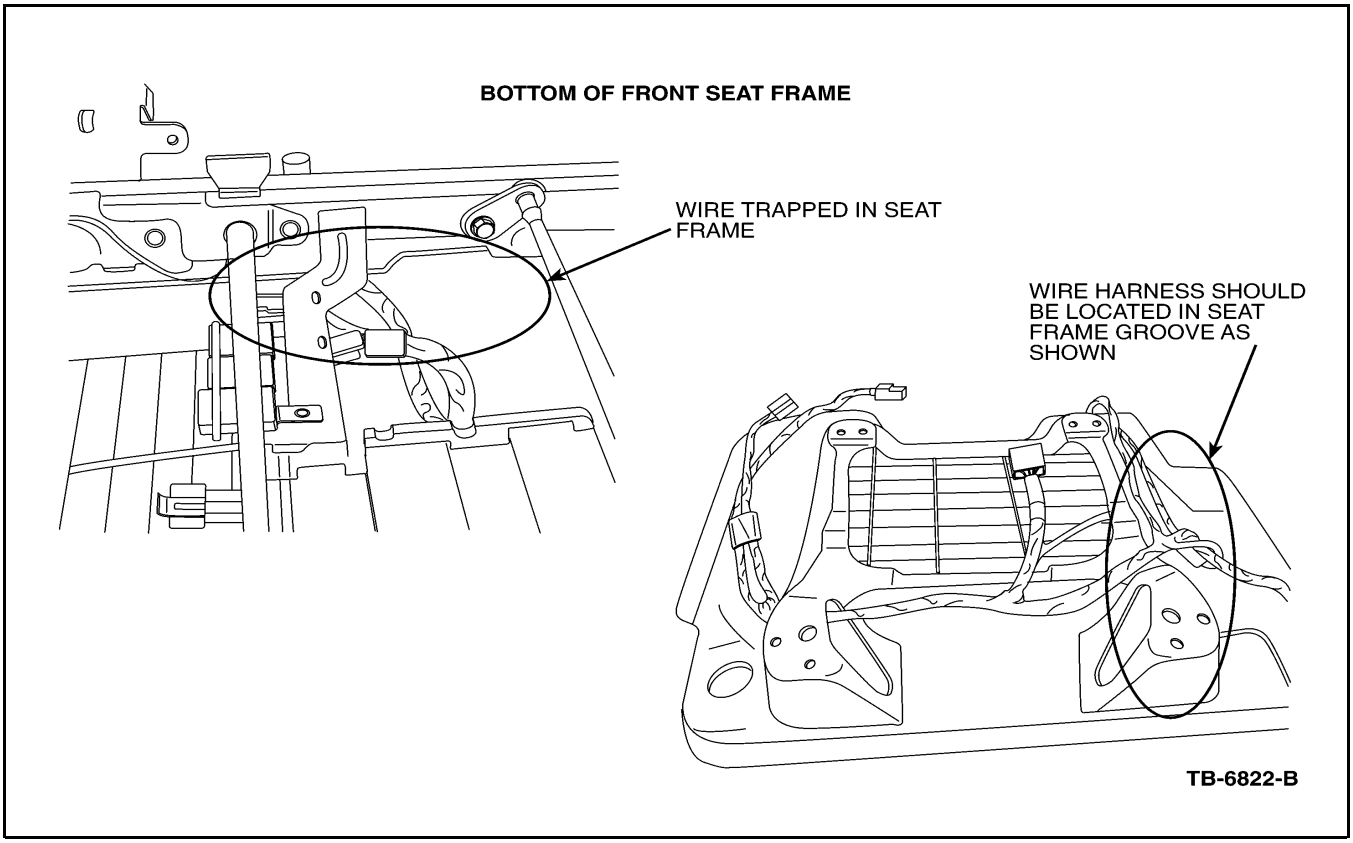
Figure 2 - Article 02-21-7

- **Seat wire routing issues - Figure 2a.** The seat wire harness may become trapped between the seat pan and tracks causing a short.
- **Seat wire routing issues - Figure 2b.** Vehicles built before 08/12/2002: The seat wire harness may have become trapped between the seat frame and front floor pan causing a short.

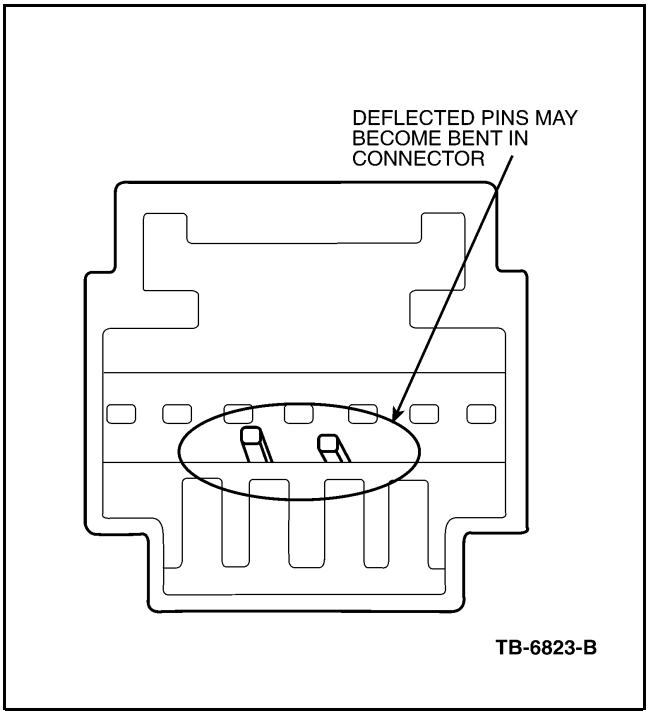
Figure 3 - Article 02-21-7

- **Side airbag connector bent pins - Figure 3.** Vehicles built between 05/07/2002 and 06/11/2002: Connectors C313 and C314 had the three cavity hardshell replaced with a four cavity hardshell. Vehicles in the date range may have twisted wires at the back of these side airbag connectors which may have caused deflected pins inside the connector. When the connectors were mated, there was a potential for bent pins. Later vehicles had the spot tape removed from the back of the side airbag connector to eliminate the potential for bent pins.

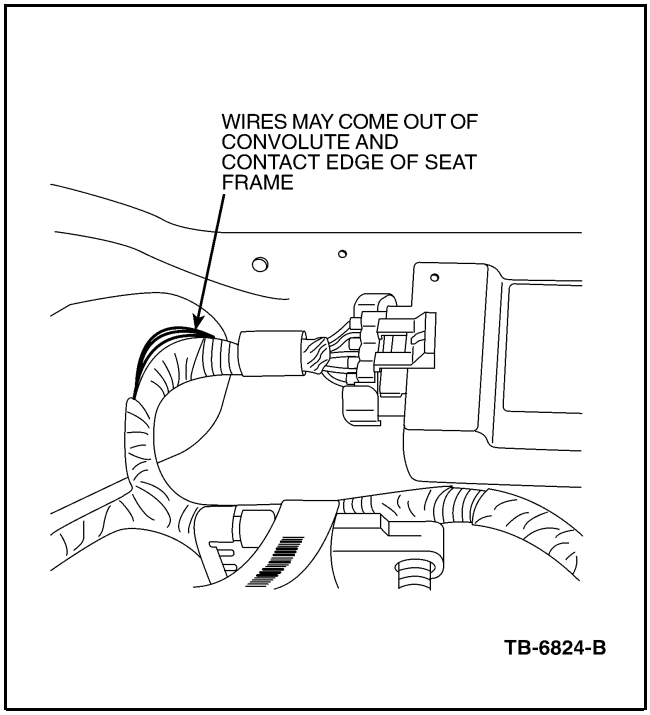
Figure 4 - Article 02-21-7

- **Short out condition at OCS (Occupant Classification System) connector - Figure 4.** Vehicles built before 08/19/2002: Wires may slip out of the protective convolute creating a potential for a short out condition against the sharp edge of the front passenger seat frame at the seat pressure sensor. Later vehicles have full tape wrap on the plastic convolute around the wire to the seat pressure sensor connector.

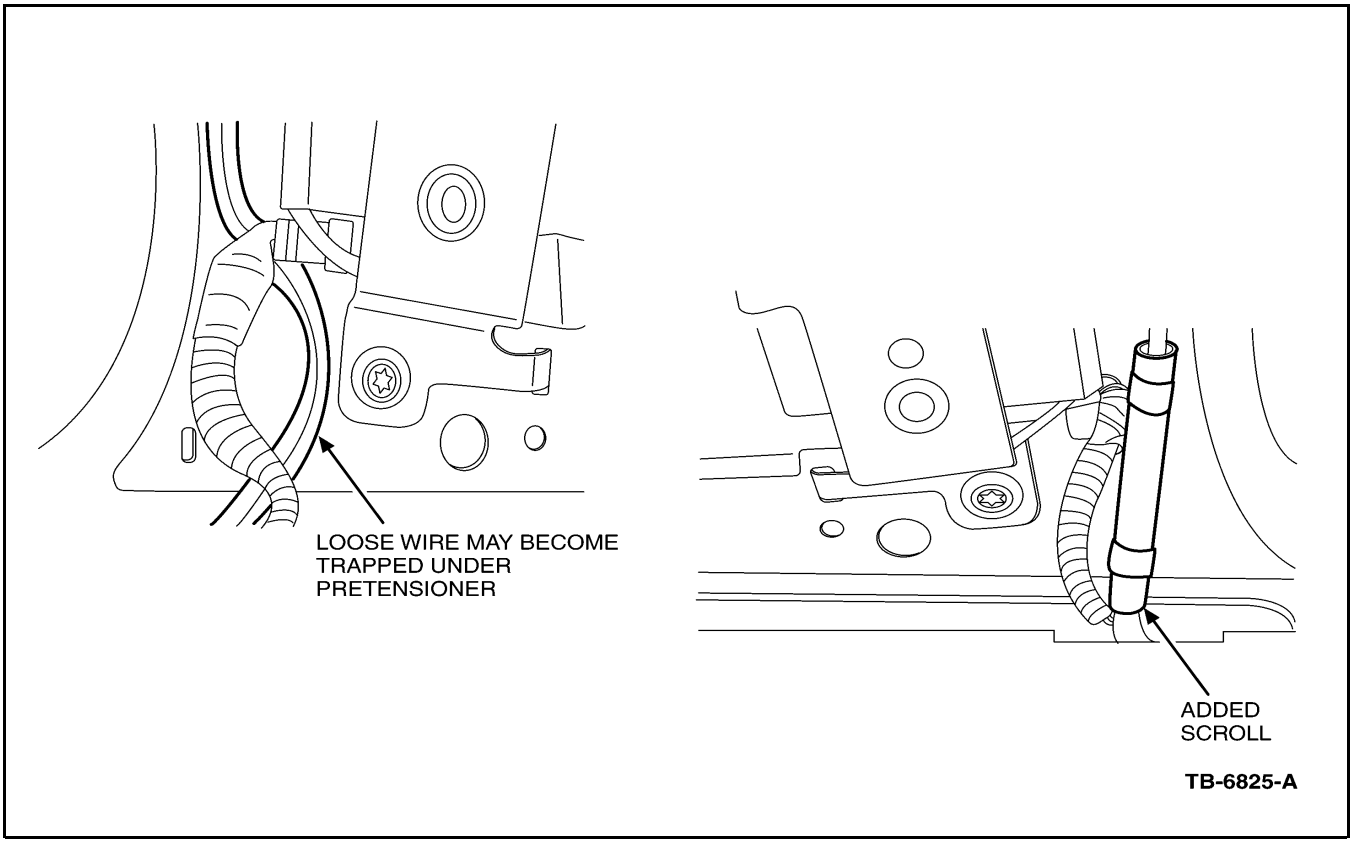
Figure 5 - Article 02-21-7

- **Short-out condition at pretensioners (left and right) - Figures 5a and 5b.** Vehicles built before 08/26/2002: The 14A005 wire harness may become trapped under the pretensioner bolt at the "B" pillar. Later vehicles have a piece of scroll added to the wire to prevent it from becoming trapped under the bolt during assembly.
