ELECTRICAL—HEADLAMP— MOISTURE/CONDENSATION IN LENS ASSEMBLY	Article No. 01-21-1

MERCURY: 2001-2002 COUGAR

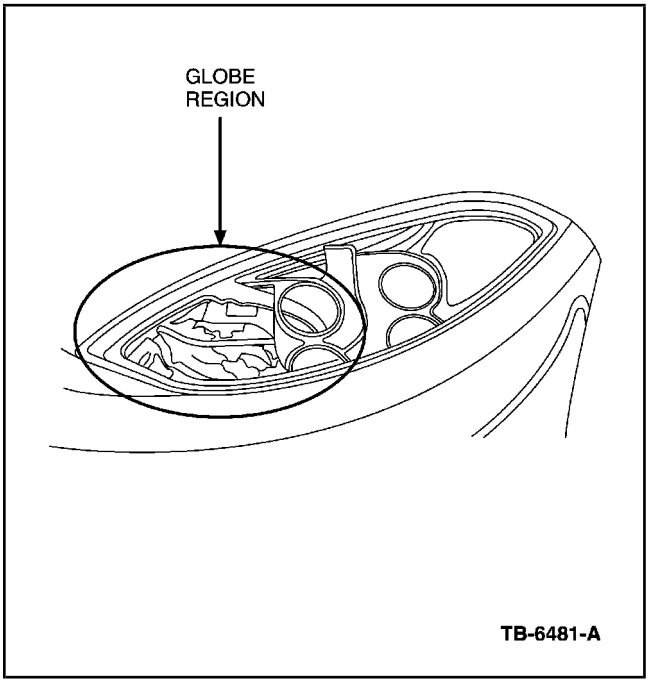
Figure 1 - Article 01-21-1

Some vehicles may exhibit condensation in the headlamps. Condensation is a natural occurring phenomenon in headlamps. This is due to the fact that headlamps have to be vented to alleviate pressure differentials on the inside and outside of the lamp.

Condensation in a headlamp can be eliminated under normal vehicle operating conditions and with the headlamps turned on for 10 minutes. The main globe region in the lamp (Figure 1) should be free of all condensate at the end of the ten minutes. If at the end of ten minutes, excessive condensate still remains in the globe region of the lamp, then the affected lamp assembly should be replaced.

Under normal operating conditions with the headlamps on, this condensation will dissipate. Refer to the following Service Information for details.
