FUEL—FUEL PUMP HANDLE SHUTS OFF WHILE FILLING BEFORE TANK IS FULL	Article No. 00-4-4

FORD: 1999-2000 WINDSTAR

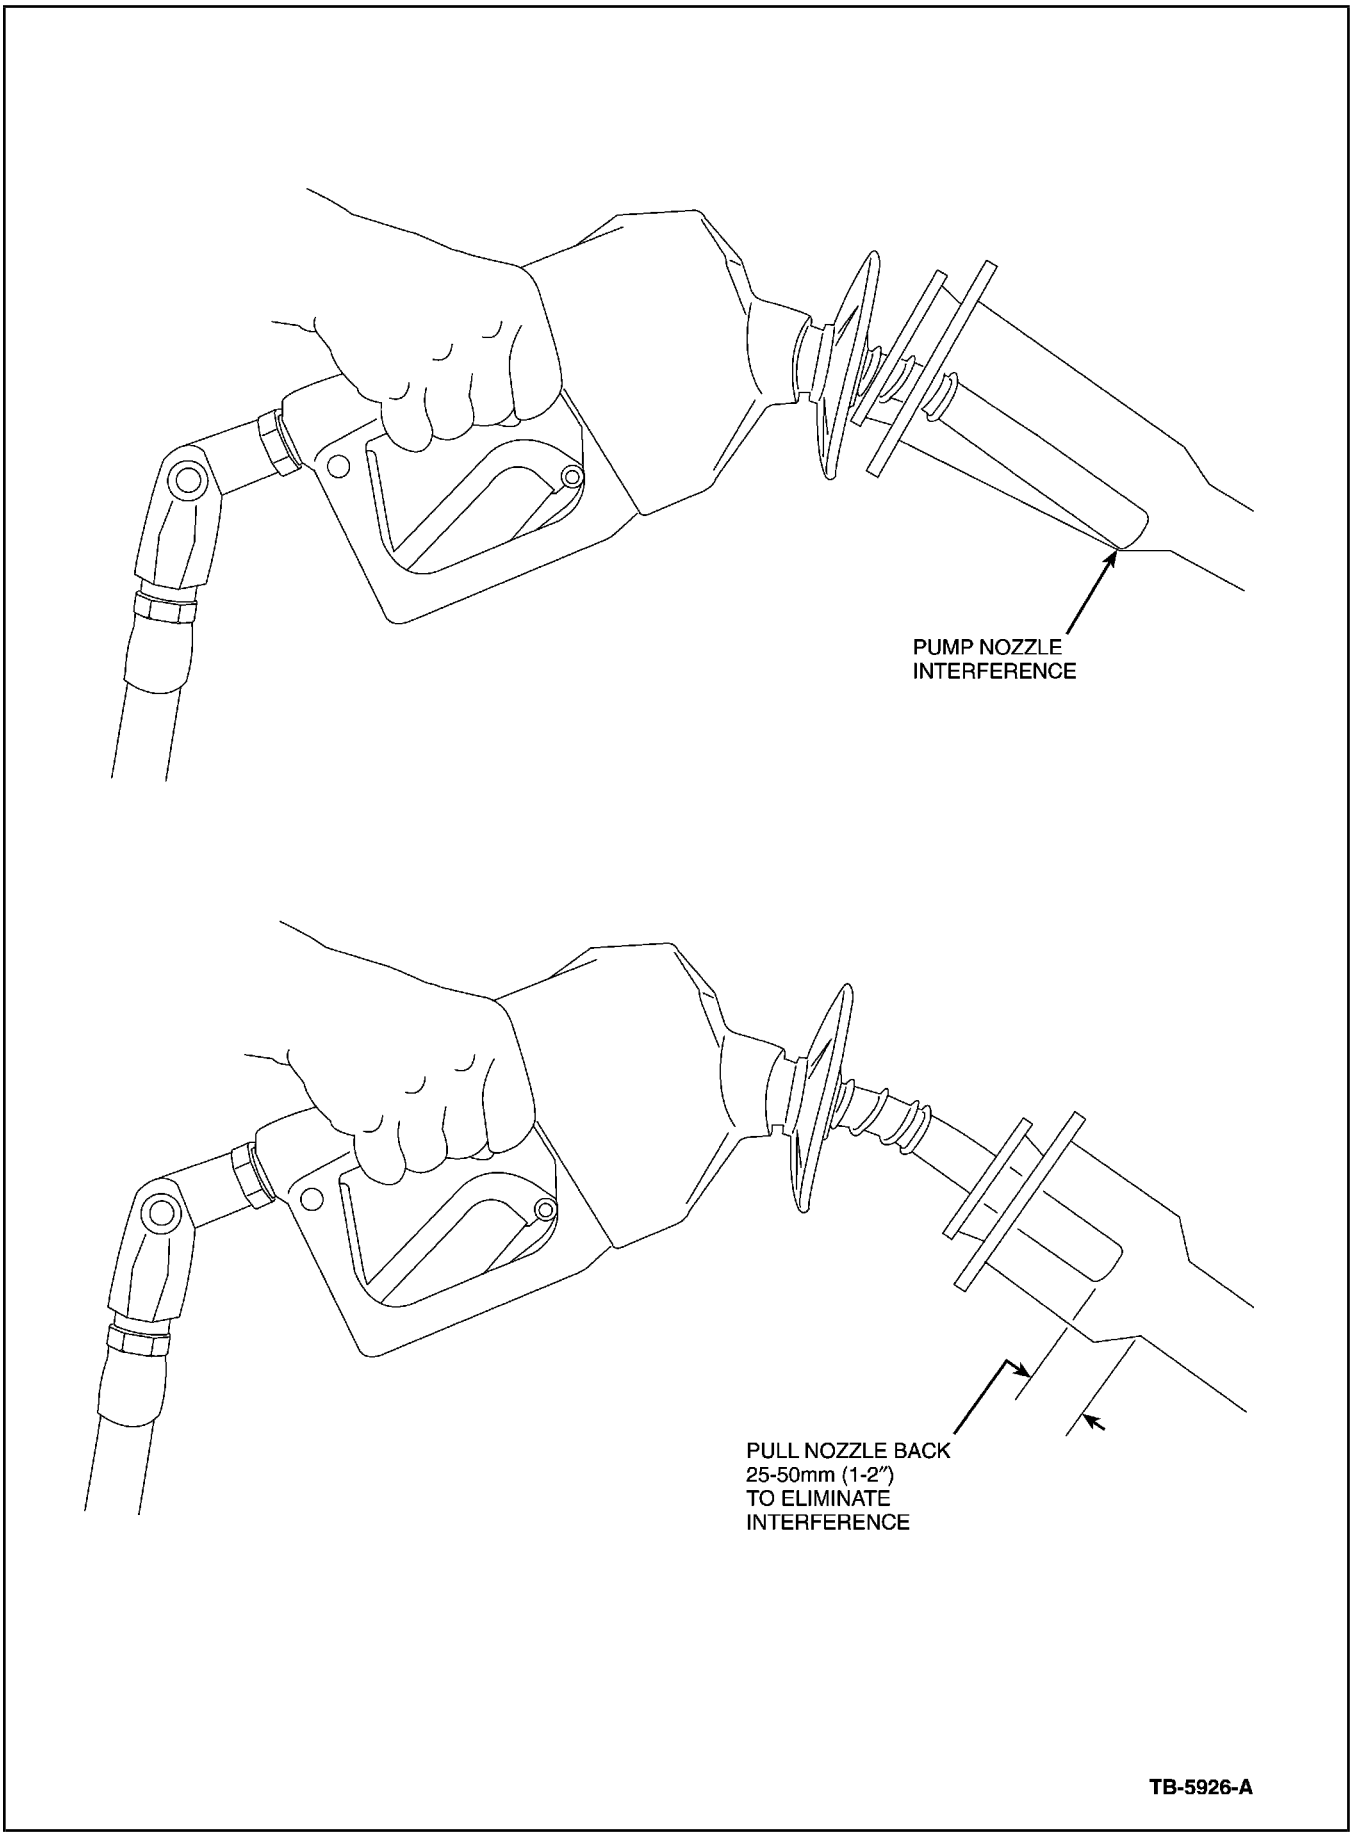
Figure 1 - Article 00-4-4

The fuel pump handle may shut off while filling vehicle before tank is full on some vehicles. This may be caused by variations in the fuel filler station pump or by obstructions in the carbon canister fresh air tube.

1. Due to differences in fuel station nozzles and fuel station pump pressures, repositioning the fuel station filler nozzle is recommended if the pump shuts off during refueling. Reposition the fuel station filler nozzle by pulling it out 25-50mm (1-2 ″) and then resume fueling (Figure 1). Repositioning the fuel station pump nozzle reduces the turbulence caused by fuel rushing into the vehicle's fuel filler pipe wall. There is a pressure transducer located in the fuel station nozzle that interprets the fuel turbulence as a full fuel tank and as designed, it will shut down the fuel pump. If the filling concern is eliminated by repositioning the fuel station pump nozzle, then the system is functioning normally and does not require repair. If repositioning the nozzle does not improve fuel filling, then proceed to Step 2.
