• **CLIMATE CONTROL—HIGH PITCHED WHISTLE NOISE FROM THE A/C PLENUM AREA—HIGHWAY SPEEDS ONLY—VEHICLES BUILT 04/04/2001 THROUGH 05/17/2001** • **NOISE—HIGH PITCHED WHISTLE NOISE FROM THE A/C PLENUM AREA—HIGHWAY SPEEDS ONLY—VEHICLES BUILT 04/04/2001 THROUGH 05/17/2001**	**Article No. 01-15-4**

FORD: 2001 CROWN VICTORIA

MERCURY: 2001 GRAND MARQUIS

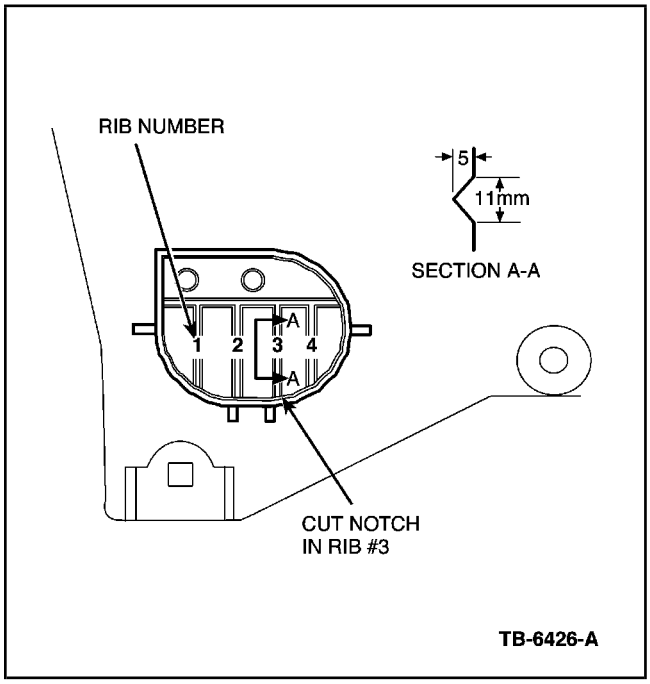
Figure 3 - Article 01-15-4

When the air inlet duct door is in the MAX A/C or OFF position, ram air on the fresh air side of the duct is exiting through the drain at the bottom of the duct and then re-entering the drain on the recirculation side of the drain. The air is flowing behind the rubber drain flap and over a molded plastic rib in the housing. The air flow through this narrow gap is generating the whistle noise.

There are 4 molded vertical ribs in the housing behind the A/C drain flap. Cut a notch in rib 3 as shown. Refer to the following Service Procedure for details.

2. Raise vehicle on hoist.
3. Remove right front wheel.
4. Loosen and remove rear fender apron screw (Figure 1).
5. Peel back fender apron to gain access to inlet air duct drain flap (Figure 2).
6. Lift A/C drain flap, 4 molded vertical ribs in the housing should be visible.
7. Cut a notch in rib number 3 (Figure 3). Use a pair of side cutters to cut the notch.
8. Place fender apron back in place.
9. Re-secure fender apron screw (11.5+/- 2.5 N•m).
10. Re-secure wheel to vehicle (115 - 142 N•m).
11. Lower vehicle from hoist.
