• CLIMATE CONTROL—"WHISTLING" NOISE HEARD FROM HEATER PLENUM • NOISE—"WHISTLING" HEARD FROM HEATER PLENUM	**Article No. 00-6-7**

FORD: 2000 FOCUS

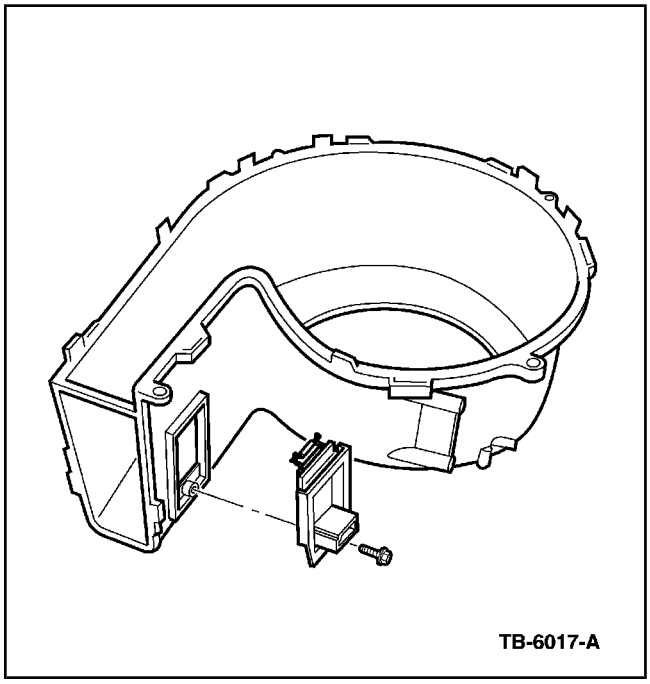
Figure 1 - Article 00-6-7

A "whistling" noise from the heater plenum near the blower motor resistor may be heard on some vehicles. This may be due to air leaking between the top leading edge of the blower motor resistor and the case.

1. Remove the blower motor resistor from the heater plenum (Figure 1).
