ENGINE—5.4L—OIL SENDING UNIT INTERFERENCE FIT AT ENGINE OIL DRIP SHIELD—4X4 VEHICLES EQUIPPED WITH 5.4L ENGINE ONLY	Article No. 01-4-2

FORD: 1998 F-250 LD
1998-2001 EXPEDITION, F-150
1999-2001 SUPER DUTY F SERIES

LINCOLN: 1998-2001 NAVIGATOR

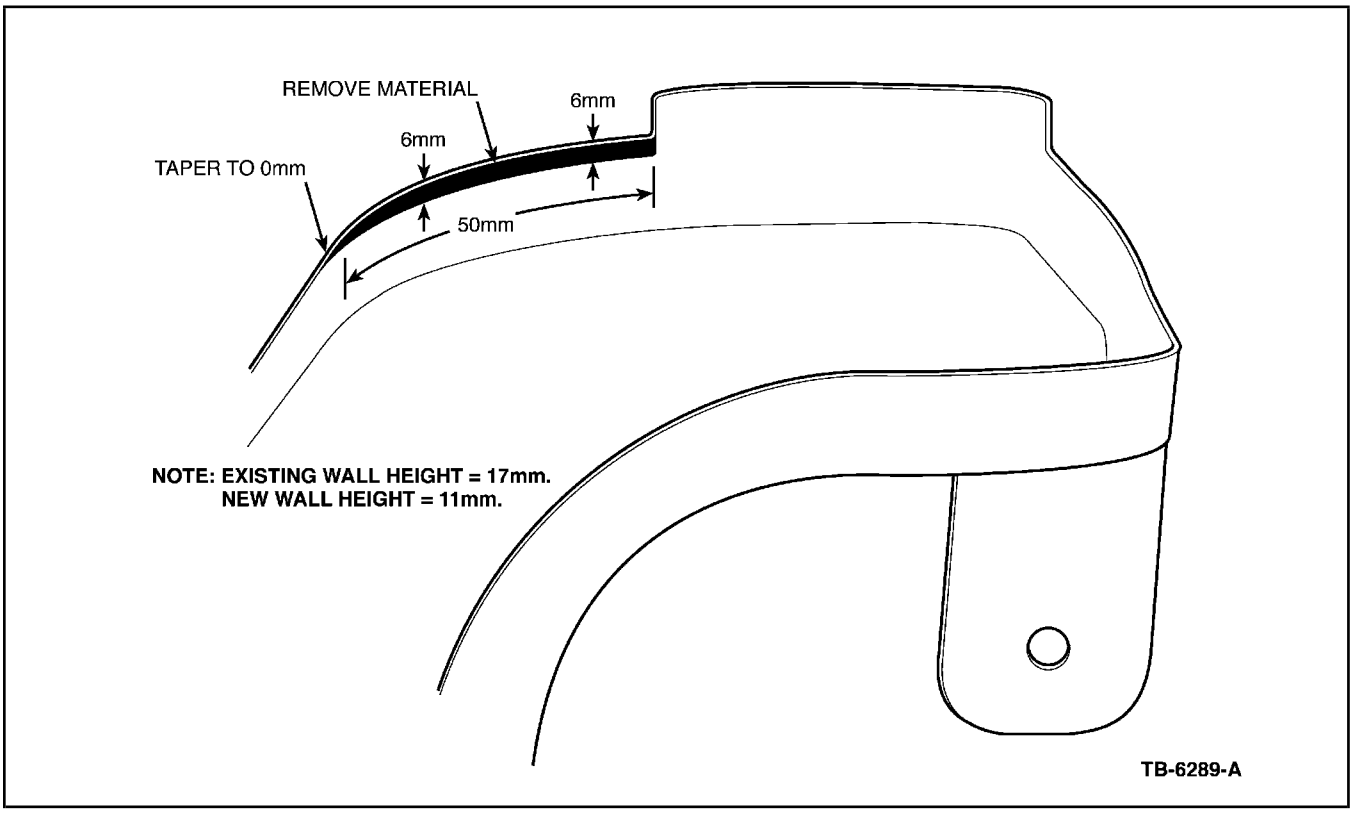
Figure 1 - Article 01-4-2

Some vehicles may exhibit the engine oil sending unit contacting the oil drip shield attached to the front axle. This may be caused by tight tolerances between the engine oil sending unit and the engine oil drip shield. This may cause a malfunction of the engine oil sending unit.

If the engine oil sending unit needs to be replaced due to contact with the drip shield, modify the engine oil drip shield as shown. Refer to the following Service Procedure for details.

1. Remove oil drip shield from front axle. This shield is attached to the front axle by three (3) bolts.
2. Modify shield as shown (Figure 1). Remove excess material from shield. Remove any sharp edges or burrs upon finishing cutting operation.
3. Reinstall engine oil drip shield.
