BRAKES—REDUCED POWER ASSIST DURING OPERATION IN FREEZING AMBIENT TEMPERATURES—LIGHTNING MODELS ONLY	Article No. 01-25-5

FORD: 1999-2001 F-150

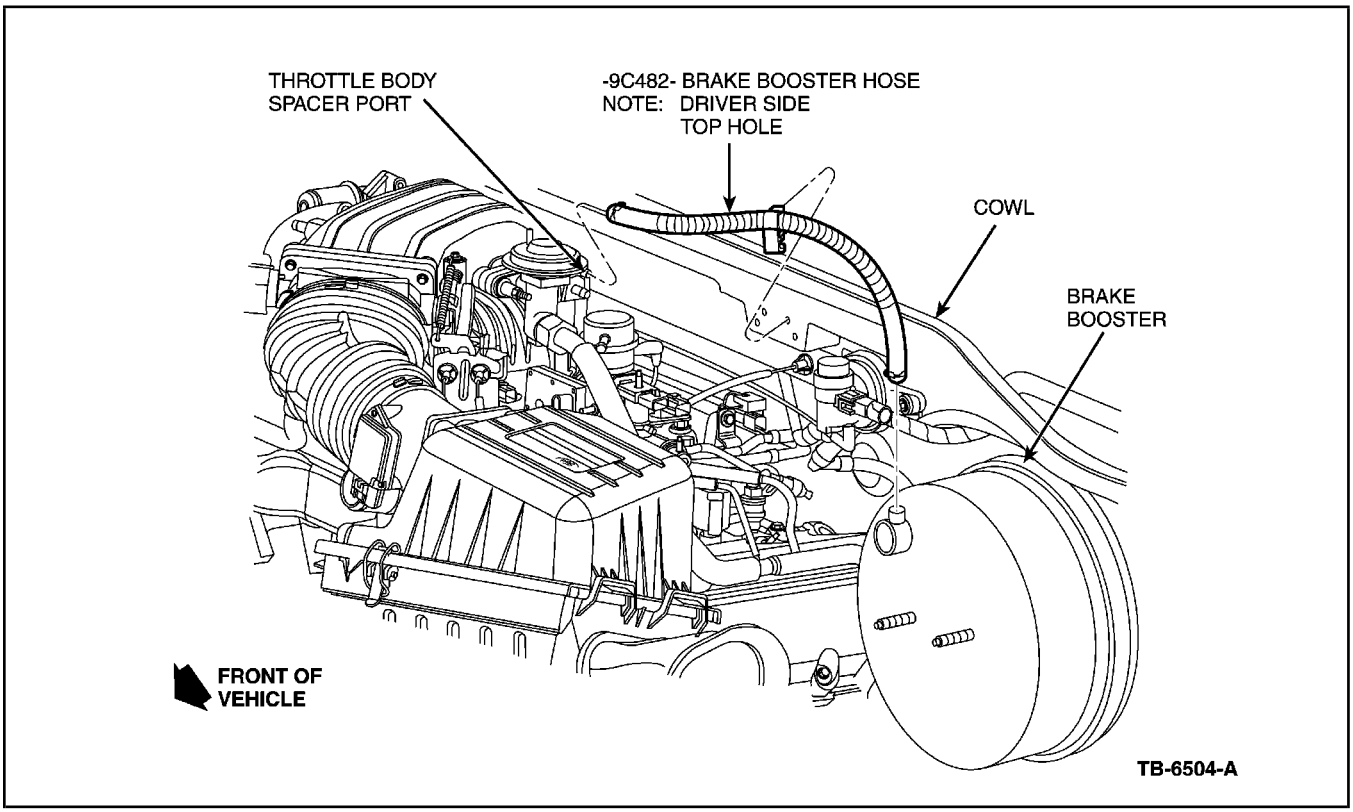
Figure 1 - Article 01-25-5

Some Lightning model vehicles may exhibit a reduced power assist after the first two or three brake applications during operation in freezing ambient temperatures. This may be caused by current production routing of the brake booster vacuum hose allowing water to collect in the hose which can freeze in cold ambient temperatures.

1. Remove existing brake booster hose and discard.
2. Install new brake booster hose (1L3Z-9C482-AA). Secure new hose by inserting retainer (included) into the upper hole on the driver's side of the cowl trim panel (Figure 1).
3. Road test and verify brake effectiveness.
