TRANSAXLE—AX4S/AX4N—REDESIGNED PARK SYSTEM—SERVICE TIP	Article No. 99-20-2

FORD: 1999-2000 TAURUS, WINDSTAR

ISSUE

1999 Taurus, Sable and Windstar vehicles with an AX4S transaxle built August 1999 and beyond and all 2000 Taurus, Sable and Windstar vehicles with AX4S or AX4N transaxles and 2000 Continental vehicles built October 1999 and beyond have a new redesigned park system in the transaxle. The parts are NOT interchangeable with the original design.

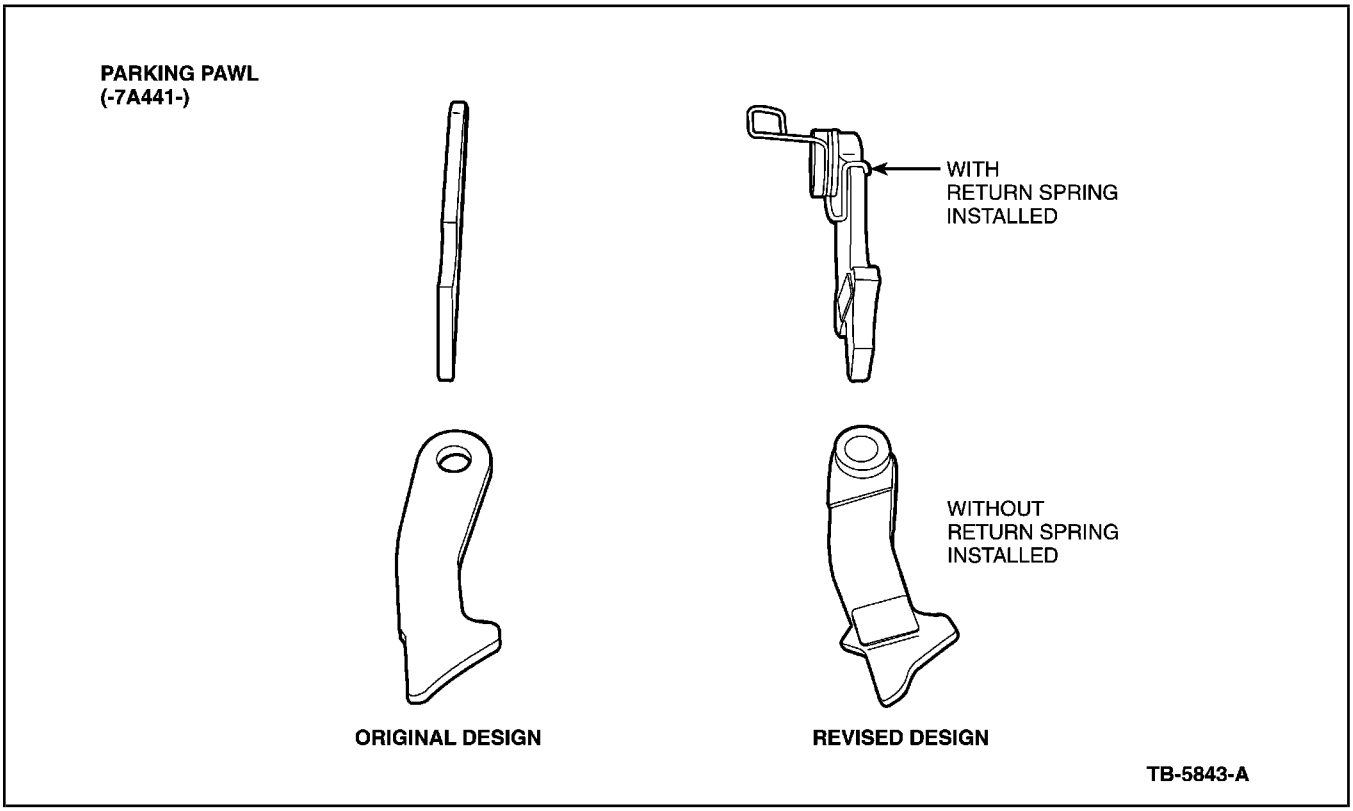
Figure 1 - Article 99-20-2

- Parking Pawl (-7A441-), Figure 1
- Parking Pawl Return Spring (-7D070-), Figure 2
- Parking Pawl Shaft (-7D071-), Figure 3
- Parking Pawl Shaft Retention Bolt (new item, AX4S only), Figure 4
- Abutment Plate (-7G101-), Figure 5
- Parking Pawl Apply Rod (-7D410-), Figure 6
- Apply Rod Inner Lever (-7A256-), Figure 7
- Detent Lever (-7A115-), Figure 8
- Detent Spring (-7E332-), Figure 9
- Manual Control Shaft (-7C493-), Figure 10
- Transaxle Case (-7005-), Figure 11
- Chain Cover (-7G188-), Figure 12
- Chain Cover Gasket (-7G303-), Figure 13
- Rear Planetary Support (-7A130-, AX4S only), Figure 14
- Lower Pan (-7A194-, AX4N only), Figure 15
- Combined Rear Lube and Differential Lube Tube (-7G084-, AX4N only), Figure 16
- Pinion Shaft in Differential Case Retaining Ring, Figure 17

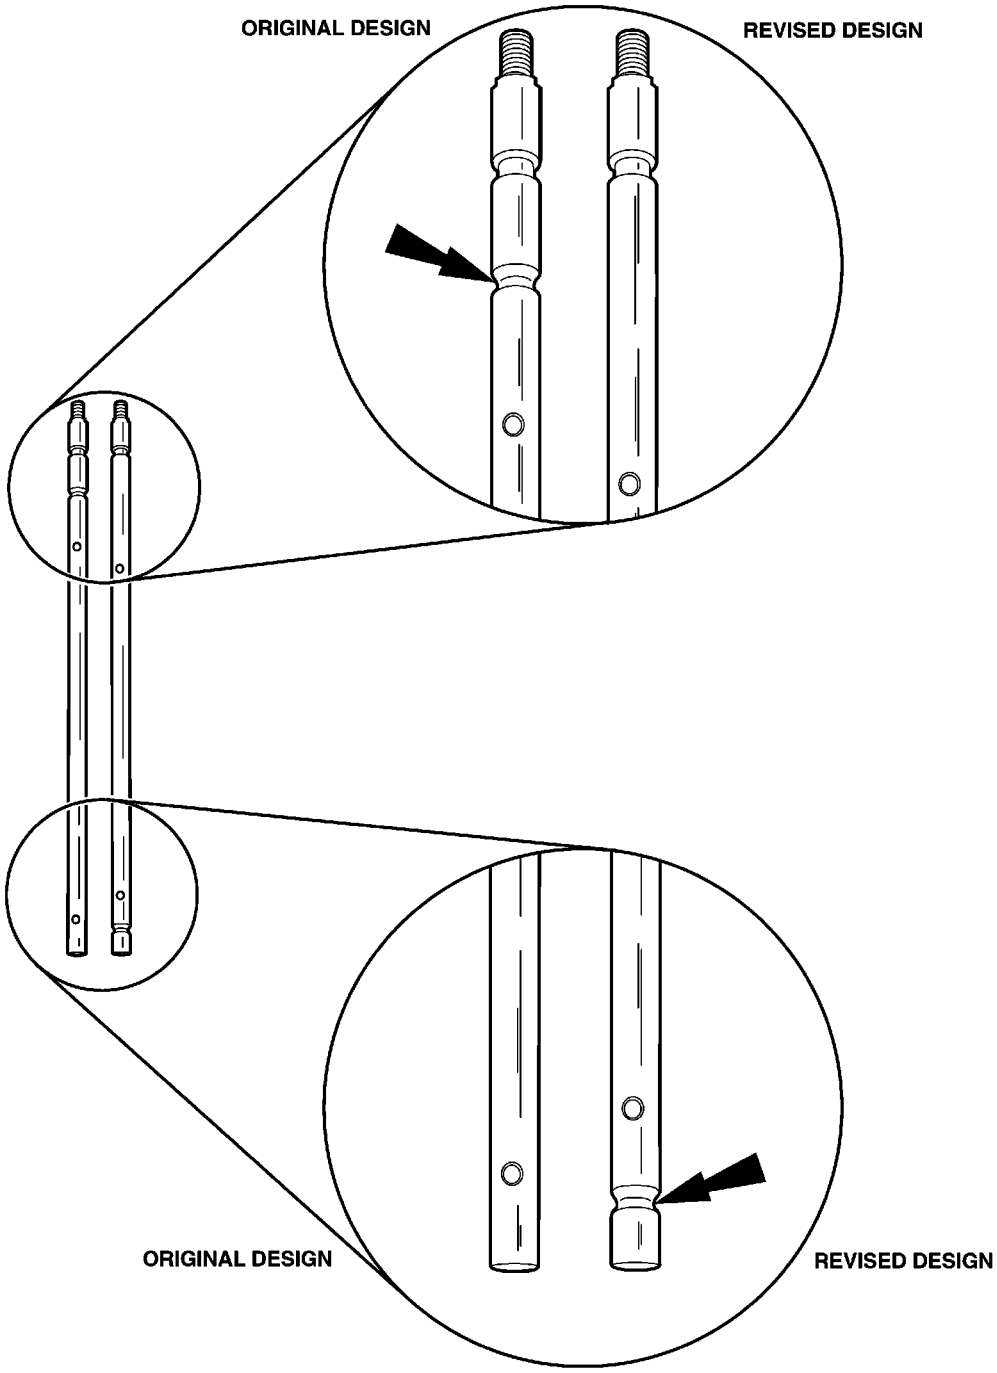
Figure 10 - Article 99-20-2

1. The roll pin locations on the manual shaft have changed and the levers on the manual shaft face the opposite direction.
2. The collar that the roll pin goes through on the two levers face inward on the new design, Figure 18.
3. The parking pawl, parking pawl return spring and the abutment plate are larger and differ in shape from the original design, Figure 19.
4. One part that may be more difficult to identify would be the Rear Planetary Support (-7A130-) on the AX4S transaxle only, refer to Figure 14.

MANUAL SHAFT
(-7C493-)
