TOWN CAR LEFT REAR SEAT BELT RETRACTOR INSPECTION

AFFECTED VEHICLES: CERTAIN 2000 MODEL YEAR TOWN CAR

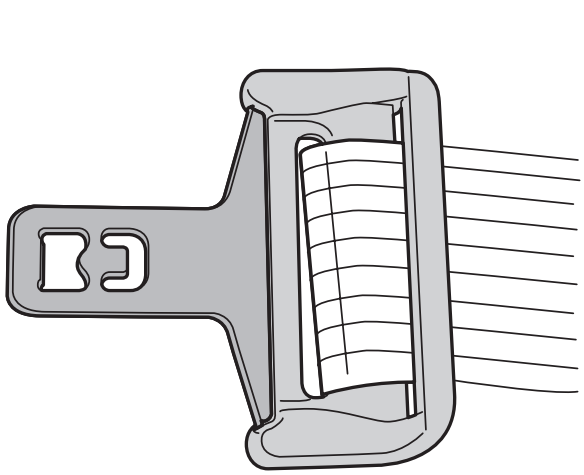
FIGURE 1

TWO (2) HOLE DESIGN
(CORRECT: DO NOT REPLACE)

1. Inspect the left rear seat belt tongue. See Figure 1.
   - If the tongue is the two (2) hole design, replacement is ***not*** required. Release the vehicle to the customer.
   - If the tongue is the one (1) hole design, replace the retractor assembly. Follow the service procedure in section 501-20A of the appropriate Workshop Manual.

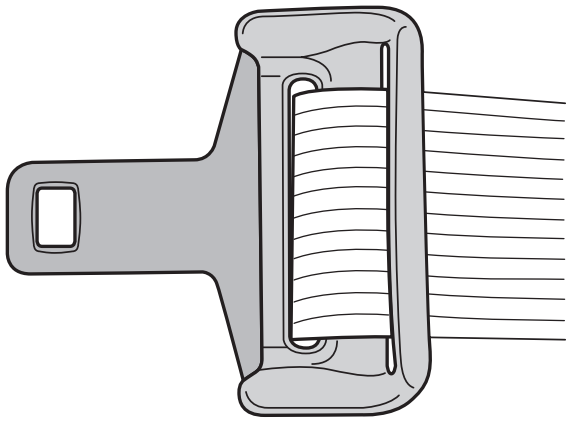
ONE (1) HOLE DESIGN
(INCORRECT: MUST BE REPLACED)
