| • **CLIMATE CONTROL—CLICKING NOISE FROM TEMPERATURE BLEND DOOR ACTUATOR—VEHICLES PRODUCED 11/13/2000 THROUGH 4/1/2001**<br>• **NOISE—CLICKING NOISE FROM CLIMATE CONTROL TEMPERATURE BLEND DOOR ACTUATOR—VEHICLES PRODUCED 11/13/2000 THROUGH 4/1/2001** | **Article No. 01-12-6** |

**FORD:** 2002 EXPLORER

**MERCURY:** 2002 MOUNTAINEER

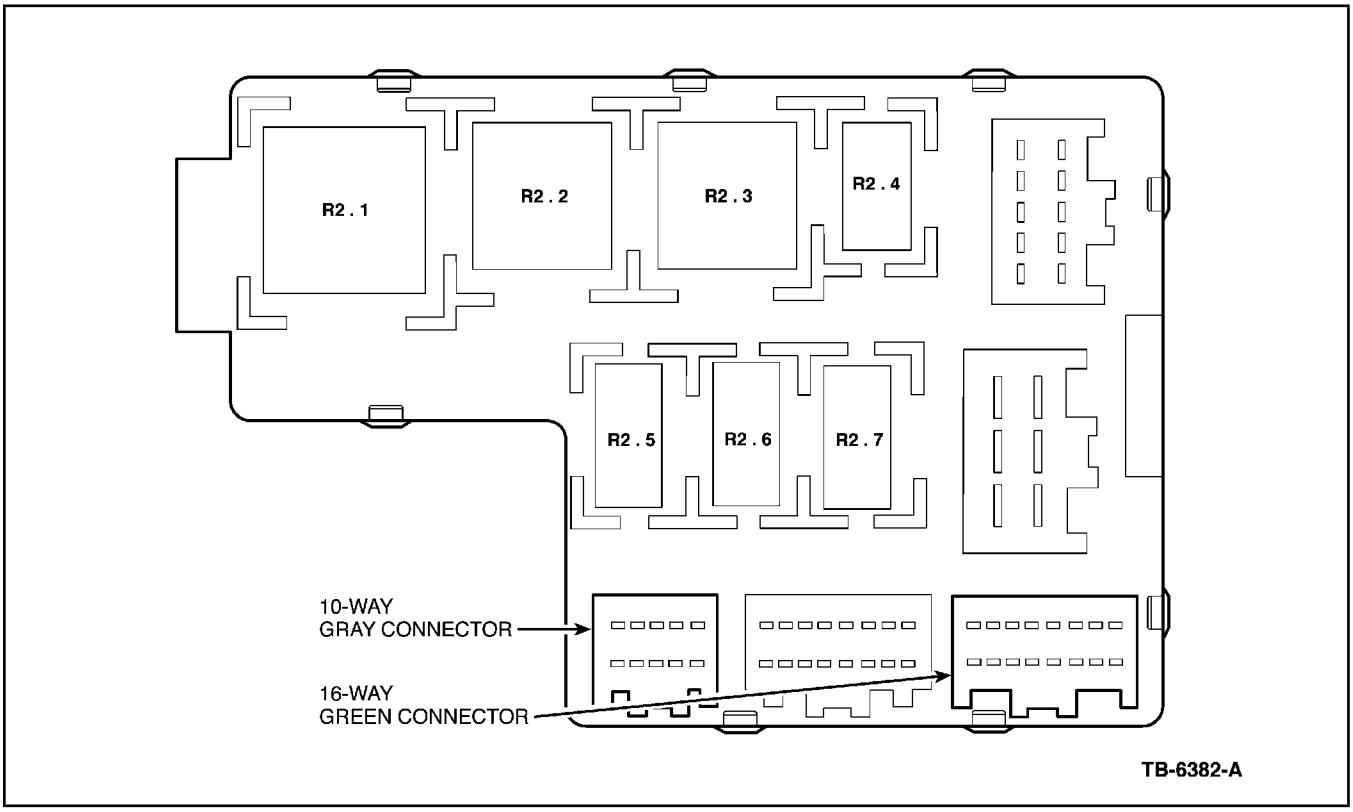
Figure 1 - Article 01-12-6

Some vehicles equipped with the manual A/C system may exhibit a continuous clicking noise from the blend door actuator when the blower speed is set at the #2 position and the temperature control knob is set between the 12:00 and 2:00 position. This may be caused by separate power sources to the blower motor & blend door actuator counteracting each other resulting in a clicking or fluttering noise.

3. On the upper side of the junction box (relay locations), locate the 16-way green connector on the outboard side of the junction box (Figure 1).
4. Remove the green connector from the junction box.

7. On the gray/yellow wire, strip the wire insulation away and prepare for a splice. This wire will be used later in the procedure.
8. Reinstall the spacer on the engagement end of the green connector and install connector in the junction box (Figure 1).

9. Locate the 10-way gray connector on the inboard side of the junction box (Figure 1).
10. Remove the gray connector from the junction box.
11. Locate cavity #2, light green/purple wire (Figure 2).

15. Install the gray connector in to the junction box (Figure 1).
16. Reposition the junction box under the instrument panel and reinstall the 3 attaching screws. Torque to 2.4 ± 0.4 N•m (21 lb-in ± 3.5 lb-in.)
