AIR CONDITIONING—LACK OF COOLING FROM DRIVER AND/OR PASSENGER SIDE VENTS—VEHICLES EQUIPPED WITH DUAL AUTOMATIC TEMPERATURE CONTROL (DATC) ONLY	Article No. 00-15-3

LINCOLN: 2000 LS

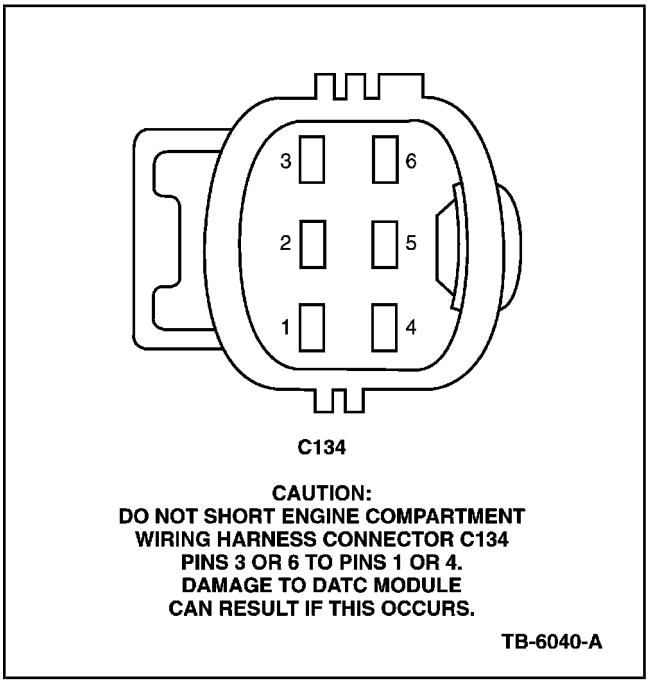
Figure 3 - Article 00-15-3

DO NOT SHORT THE ENGINE COMPARTMENT WIRING HARNESS CONNECTOR C134 PINS 3 OR 6 TO PINS 1 OR 4. DAMAGE TO THE DATC MODULE CAN RESULT IF THIS OCCURS.

4. Verify voltage to the coolant valve. Disconnect connector C134 (Figure 2). With the engine running and the DATC set to 15°C (60°F), measure the voltage between the engine compartment harness connector C134 Pin 4 (Figure 3) and ground. If voltage is less than 10 volts, repair circuit 30-FBs. If voltage is greater than 10 volts, proceed to Step 5.

6. Verify the first DATC ground circuit. With connector C134 disconnected, engine running and the DATC set to 15°C (60°F), measure the voltage between engine compartment harness C134 Pin 6 (Figure 3) and the auxiliary junction box fuse terminal F124 (circuit 30-KA23). If voltage is greater than 10 volts, proceed to Step 7. If voltage is less than 10 volts, inspect circuit 91S-FB4 for high resistance or an open circuit between connector C134 Pin 6 and connector C228b Pin 6 at the DATC module. Repair as required. If circuit 91S-FB4 is OK, install a new DATC module.

7. Verify the second DATC ground circuit. With connector C134 disconnected, engine running and the DATC set to 15°C (60°F), measure the voltage between engine compartment harness C134 Pin 3 (Figure 3) and the auxiliary junction box fuse terminal F124 (circuit 30-KA23). If voltage is greater than 10 volts, proceed to Step 8. If voltage is less than 10 volts, inspect circuit 91S-FB3 for high resistance or an open circuit between connector C134 Pin 3 and connector C228b Pin 5 at the DATC module. Repair as required. If circuit 91S-FB3 is OK, install a new DATC Module (XW4Z-19980-CA).
