| • **DRIVEABILITY—DIAGNOSTIC TROUBLE CODES (DTC) P0500, P1502 AND/OR U1039 CONTINENTAL MODELS ONLY—STICKING OR BINDING IGNITION LOCK CYLINDER—HIGH EFFORT WHEN TURNING IGNITION SWITCH**<br>• **ELECTRICAL—STICKING OR BINDING IGNITION LOCK CYLINDER—HIGH EFFORT WHEN TURNING IGNITION SWITCH** | **Article No. 01-21-13** |

## Article No. 01-21-13 Cont'd.

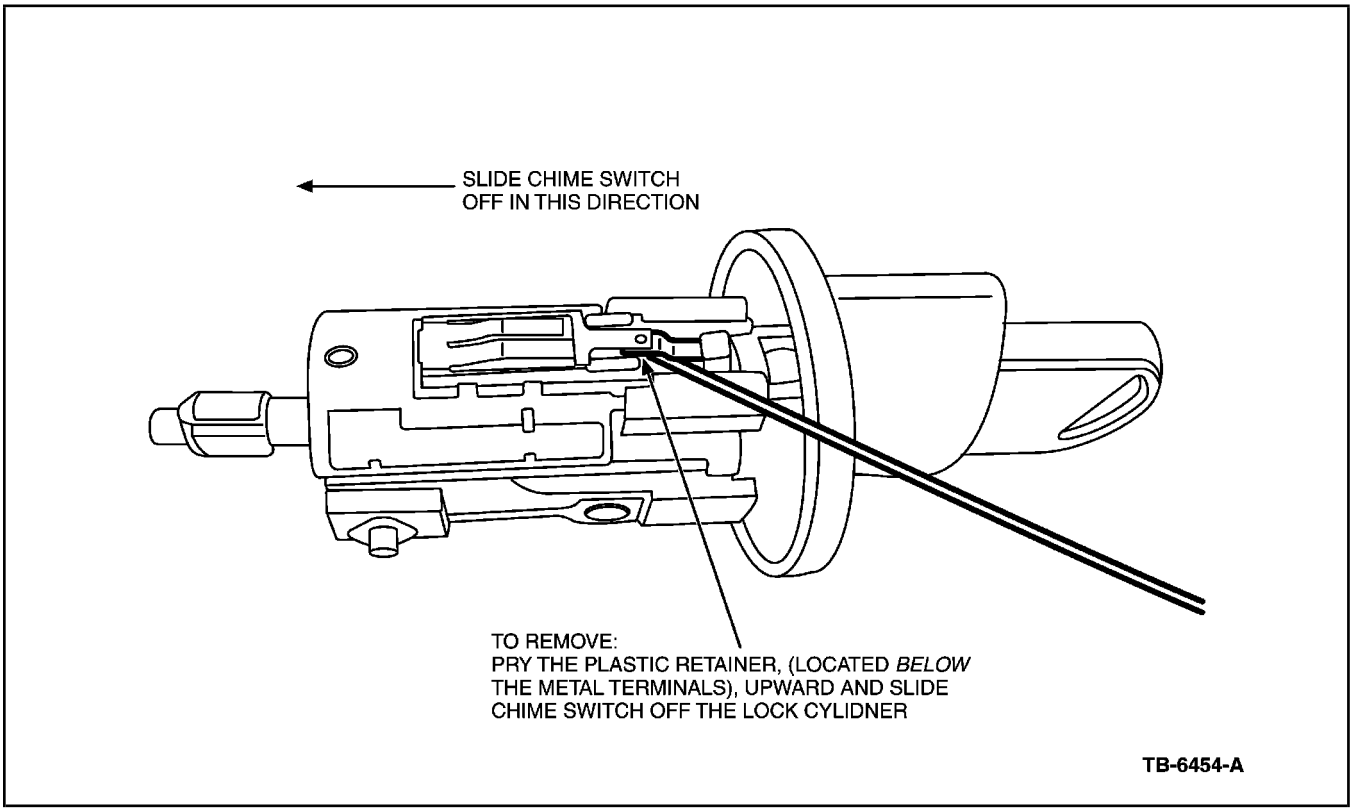
Figure 1 - Article 01-21-13

4. Remove the Plastic Key chime warning switch by prying upward on the plastic retainer, while sliding the switch away from the key insertion end (Figure1). Refer to the appropriate model Workshop Manual, Key-in-ignition warning switch removal and installation section located in Section 413 if additional detail is required.

5. Install a new Key-In-Ignition warning chime switch XL2Z-11A127-AB and reinstall lock cylinder.
6. Verify proper function of the Ignition Switch Lock Cylinder and Key-In-Ignition warning chime switch.
