ELECTRICAL—HEAVY STATIC OR SIGNAL LOSS ON TWO WAY RADIO COMMUNICATION—BI-FUEL LPG VEHICLES ONLY

Article No. 02-21-5

FORD: 2001-2002 F-150

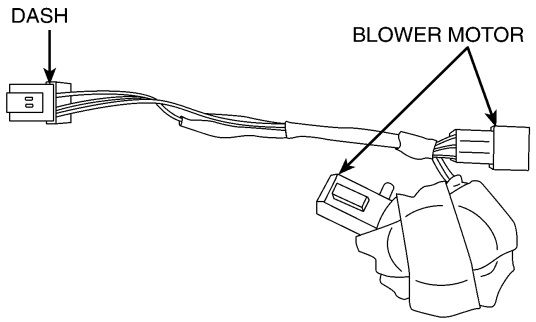
Figure 1 - Article 02-21-5

Some 2001-2002 Bi-Fuel F-150's may exhibit heavy static and possible loss of signal on customer installed two-way radios operating in the range of 47 MHz. Operation of HVAC blower motor and windshield wipers may increase severity of symptoms. This may be caused by the Compuvalve and Blower Motor Harness.

1. Replace the Compuvalve 2L3Z-9F954-AE. Refer to Section 303-04D in Workshop Manual.
2. Replace HVAC blower harness 3L3Z-18B574-AA (Figure 1).
   a. Remove connector from blower motor behind dash, right hand side of vehicle.
   b. Unplug the two connectors and remove short (8 inch) harness containing the blower connector.
   c. Install blower connector to blower motor.
   d. Reconnect remaining two connectors.
