• **SUSPENSION—SQUEAK NOISE FROM REAR LEAF SPRINGS—REPLACEMENT REAR LEAF SPRING TIP LINER—VEHICLES PRODUCED BEFORE 10/15/01** • **NOISE—SQUEAK NOISE FROM REAR LEAF SPRINGS—REPLACEMENT REAR LEAF SPRING TIP LINER—VEHICLES PRODUCED BEFORE 10/15/01**	**Article No. 02-14-1**

FORD: 1999-2002 SUPER DUTY F-53 STRIPPED CHAS.

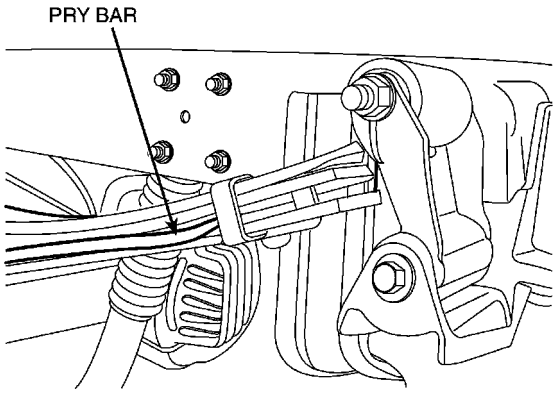
Figure 1 - Article 02-14-1

Some vehicles built before 10/15/2001 may exhibit a squeak noise from the rear leaf springs. This may be caused by the spring tip liners becoming dislodged or cracked in the spring leafs.

To service rear spring tip liners, remove load from rear suspension. To remove the spring tip liners, it is necessary to pry the leaf springs apart individually, and remove and install liners one at a time (Figure 1). After removal of original spring tip liners, install new spring tip liners service part number 2C3Z-5586-BA ensuring that the clips are firmly located in the corresponding holes.
