TRIM—DIP IN CENTER OF INSTRUMENT PANEL	Article No. 02-1-7

FORD: 2001 ESCAPE

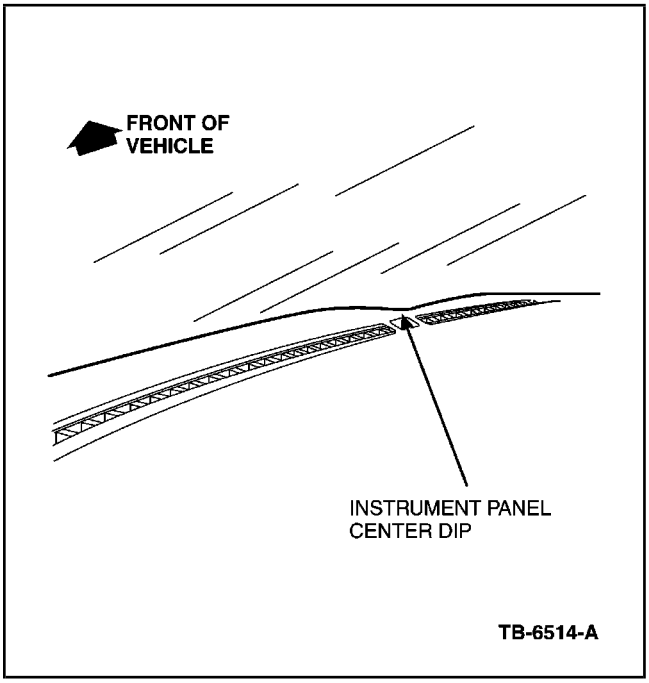
Figure 1 - Article 02-1-7

Some vehicles may exhibit a dip in the center of the Instrument Panel. This may be caused by the Instrument Panel having a low attachment point with the steel body bracket.

Identify the dip condition (Figure 1).
