AIR CONDITIONING—BLOWER MOTOR INOPERATIVE	Article No. 00-3-1

LINCOLN: 1998-2000 TOWN CAR

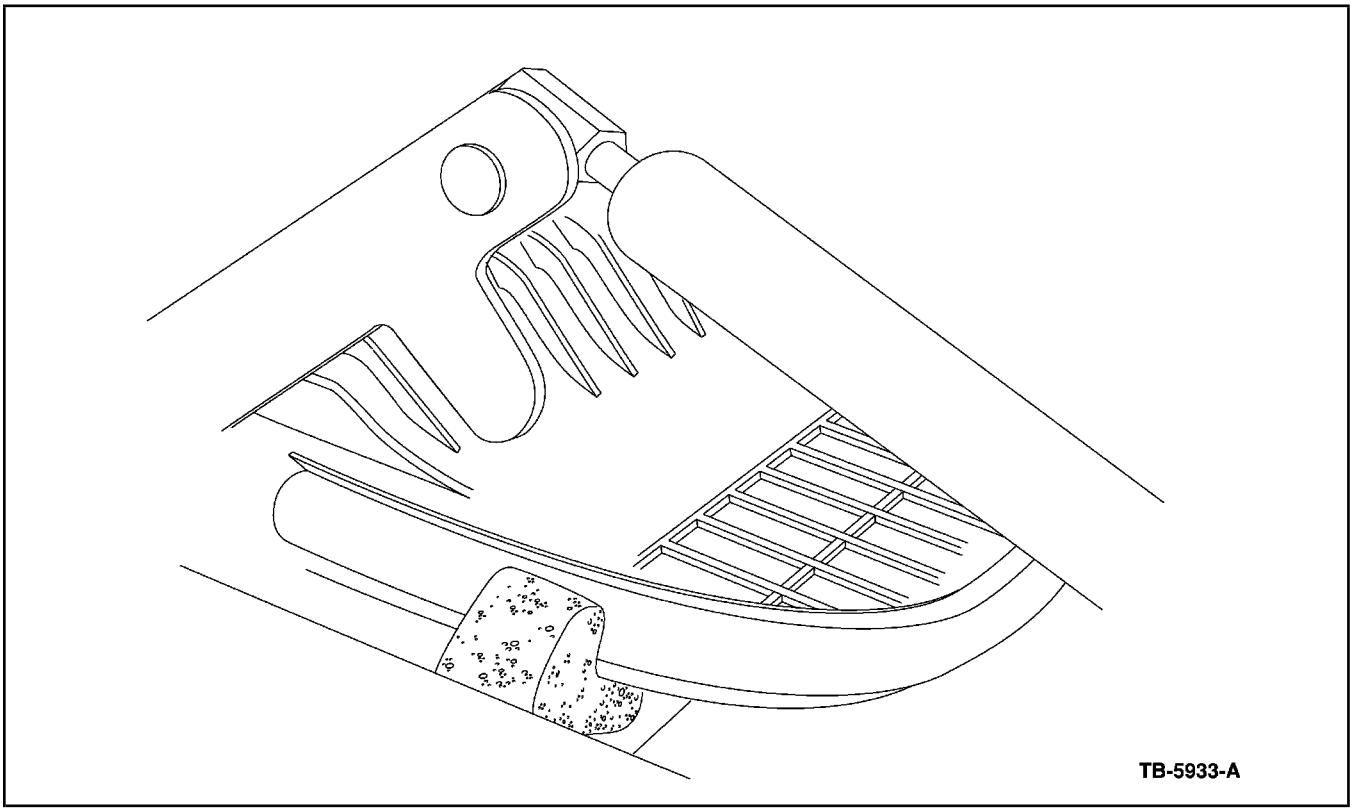
Figure 1 - Article 00-3-1

The A/C blower motor may be inoperative. This may be caused by water entry into the blower motor housing due to a mispositioned or missing foam water block.

1. Replace the Blower Motor (YW1Z-19805-CA) as outlined in the appropriate Town Car Workshop Manual.
2. Verify the foam water block is installed in the correct position.
3. If the water block is out of position, reposition the foam water block.
4. If the water block is missing, install a new Foam Water Block (XW1Z-54020A20-AA) in the correct position. Refer to Figures 1 and 2.
