DRIVEABILITY—BI-FUEL—NO START IN ALT FUEL MODE—ALT FUEL SWITCH INDICATOR ON THEN OFF WHILE CRANKING—SOLENOID TANK VALVE COIL NOW AVAILABLE SEPARATELY FOR SERVICE	Article No. 02-1-8

FORD: 2000-2001 SUPER DUTY F SERIES

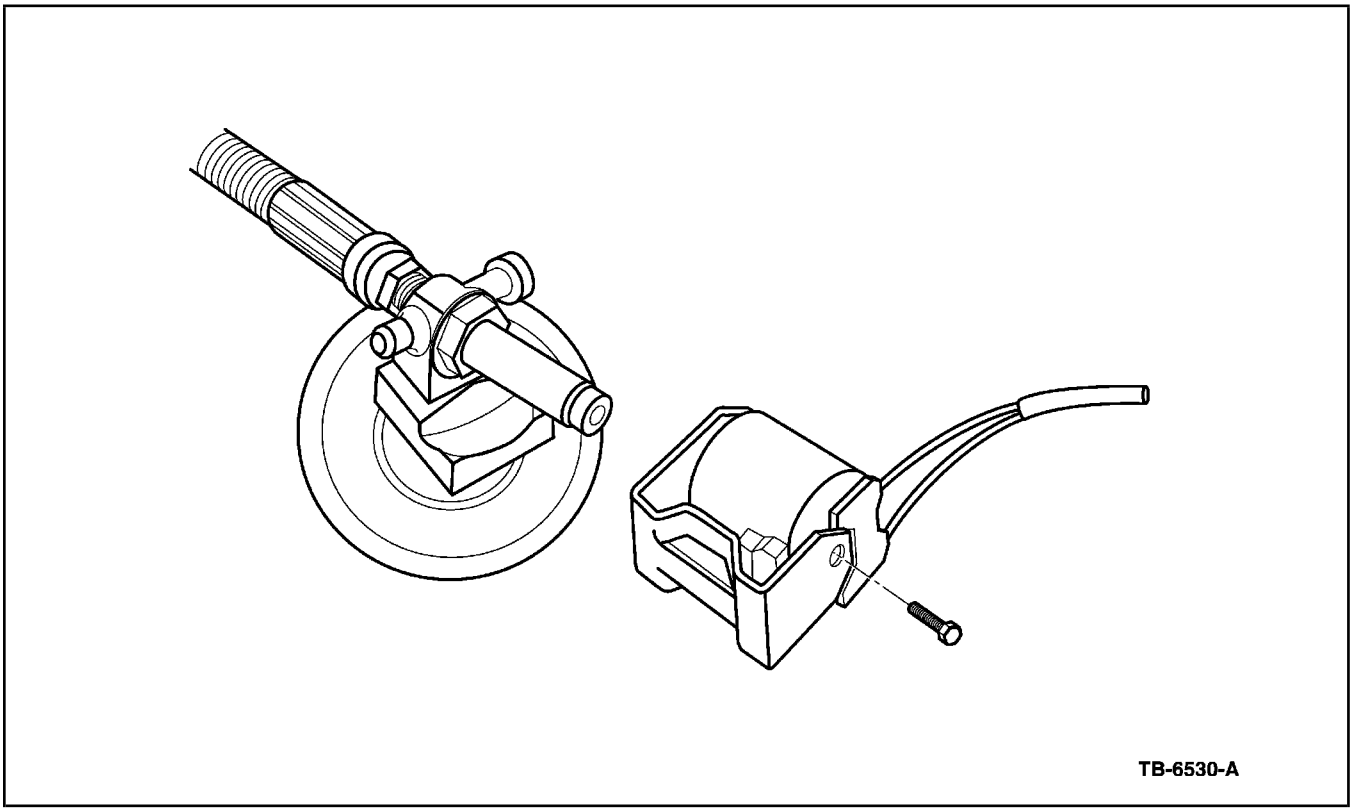
Figure 1 - Article 02-1-8

Some Bi-Fuel vehicles may exhibit a No Start in alt fuel mode. This may be caused by an electrical failure of the solenoid tank valve coil due to corrosion. It is no longer necessary to replace the entire fuel tank assembly. The solenoid coil assembly is now available for service separately.

c. Remove the small end bolt and coil harness assembly. Note the orientation of the coil for reference during installation of the new coil (Figure1).
    d. Wipe clean the solenoid plunger and install the new coil.
    e. Orient the coil and torque the bolts to 4-7 N•m (3-5 lb-ft).
    f. Connect the tank valve electrical connector.
