ENGINE—OIL LEAK FROM POSITIVE CRANKCASE VENTILATION (PCV) VALVE AREA—VEHICLES BUILT BEFORE 5/17/2002 EQUIPPED WITH 4.6L 2V ENGINE ONLY

Article No. 02-17-2

FORD: 2002 MUSTANG

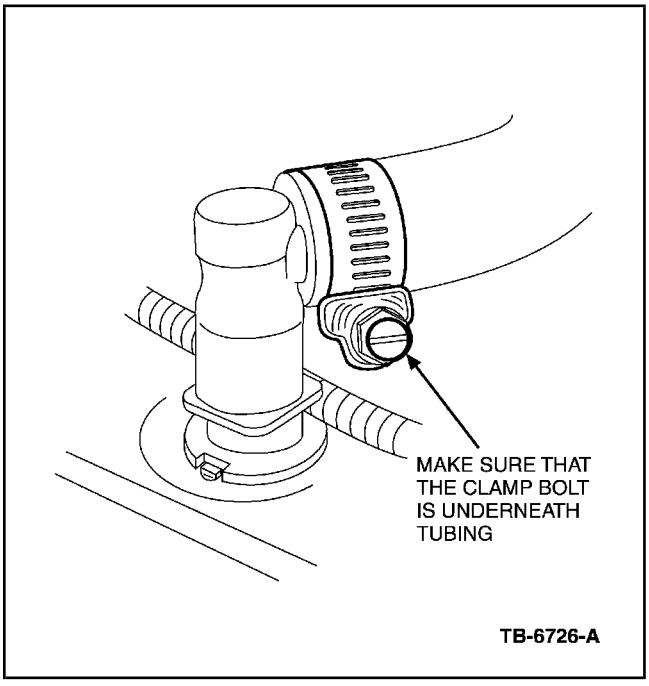
Figure 1 - Article 02-17-2

Some vehicles equipped with a 4.6L 2V engine built before May 17, 2002, may exhibit an oil leak coming from the camshaft/valve cover area, where the positive crankcase ventilation (PCV) valve mounts. This leak may be caused by the stack up tolerance between the PCV valve and tube assembly.

Verify condition. To service, install hose clamp onto the PCV tube assembly at the PCV valve. Refer to the following Service Procedure for details.

1. Verify that oil is present on the cam cover area.
2. If oil is present, remove the Air cleaner outlet tube per the Workshop Manual (Section 303-12-3).
3. Disconnect the tube from the PCV valve per the Workshop Manual (Section 303-08-7).
4. Install hose clamp (376240-S100) onto tube assembly, with the worm gear down (Figure 1).
5. Re-install tube assembly onto the PCV valve per the Workshop Manual.
6. Tighten the hose clamp to 12-20 Lb-in (1.3-2.3 N•m).
7. Re-install air cleaner outlet tube per the Workshop Manual.
8. Clean excess oil from the cam cover area.
9. Check to make sure the engine has the proper oil level.
10. Verify repair.
