- **TRANSAXLE—AX4S—HARSH 3-2 DOWNSHIFT WHEN COASTING AROUND A CORNER AND THEN ACCELERATING—SERVICE TIP**
- **TRANSAXLE—AX4S—SHUDDER WHEN ACCELERATING THROUGH A TURN—SERVICE TIP**

Article No. 99-18-4

FORD: 1995-2000 TAURUS, WINDSTAR

MERCURY: 1995-2000 SABLE

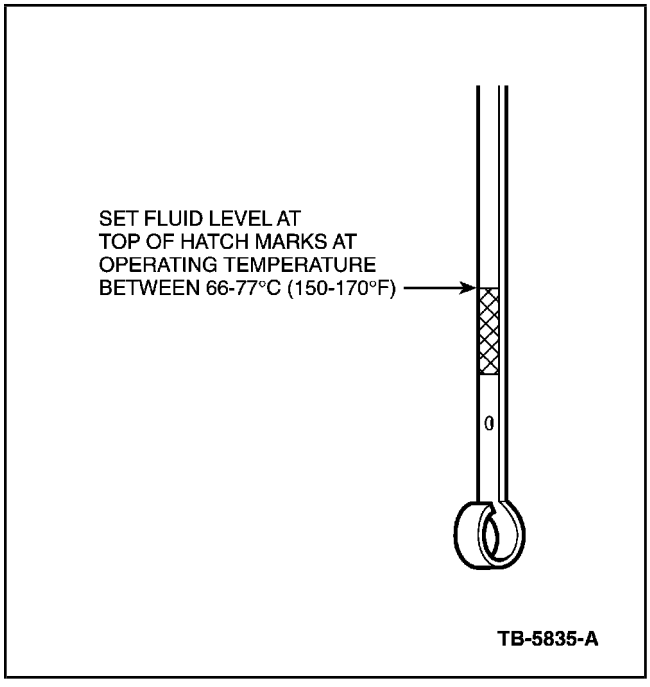
Figure 1 - Article 99-18-4

A harsh 3-2 downshift when coasting around a corner and then accelerating away from the corner may occur on some vehicles. Another condition may be a shudder on turns if the throttle is held to accelerate through the turn. Both conditions are caused by air entering the fluid filter pickup area during the turn due to low fluid level.

The fluid level in the AX4S transaxle should be set at the top end of the hatch marks on the dipstick (Figure 1) while the transaxle is at operating temperature. The vehicle must be on level ground, in Park, with the engine at idle and at operating temperature to get an accurate fluid level reading. If the fluid level is not at the top of the hatch marks, add fluid until it is at the top of the hatch marks (Figure 1). Refer to the information printed on the dipstick and/or the Owner's Guide for the correct type ATF fluid (MERCON® or MERCON® V) to add to the transaxle. Check the label of the container of ATF being used to verify if the fluid is qualified for MERCON® and so labeled; or is qualified for MERCON® V and is so labeled. In the event a fluid is qualified for both and is so labeled, it may be used in either application.
