- **AIR CONDITIONING—"FLUTTERING" NOISE FROM DEFROST DOOR DURING A/C FULL COOL MODE AND BLOWER MOTOR ON HIGH—VEHICLES BUILT THROUGH 1/1/2000**
- **NOISE—"FLUTTERING" HEARD WITH A/C FULL COOL MODE AND BLOWER MOTOR ON HIGH—VEHICLES BUILT THROUGH 1/1/2000**

Article No. 00-6-6

FORD: 2000 FOCUS

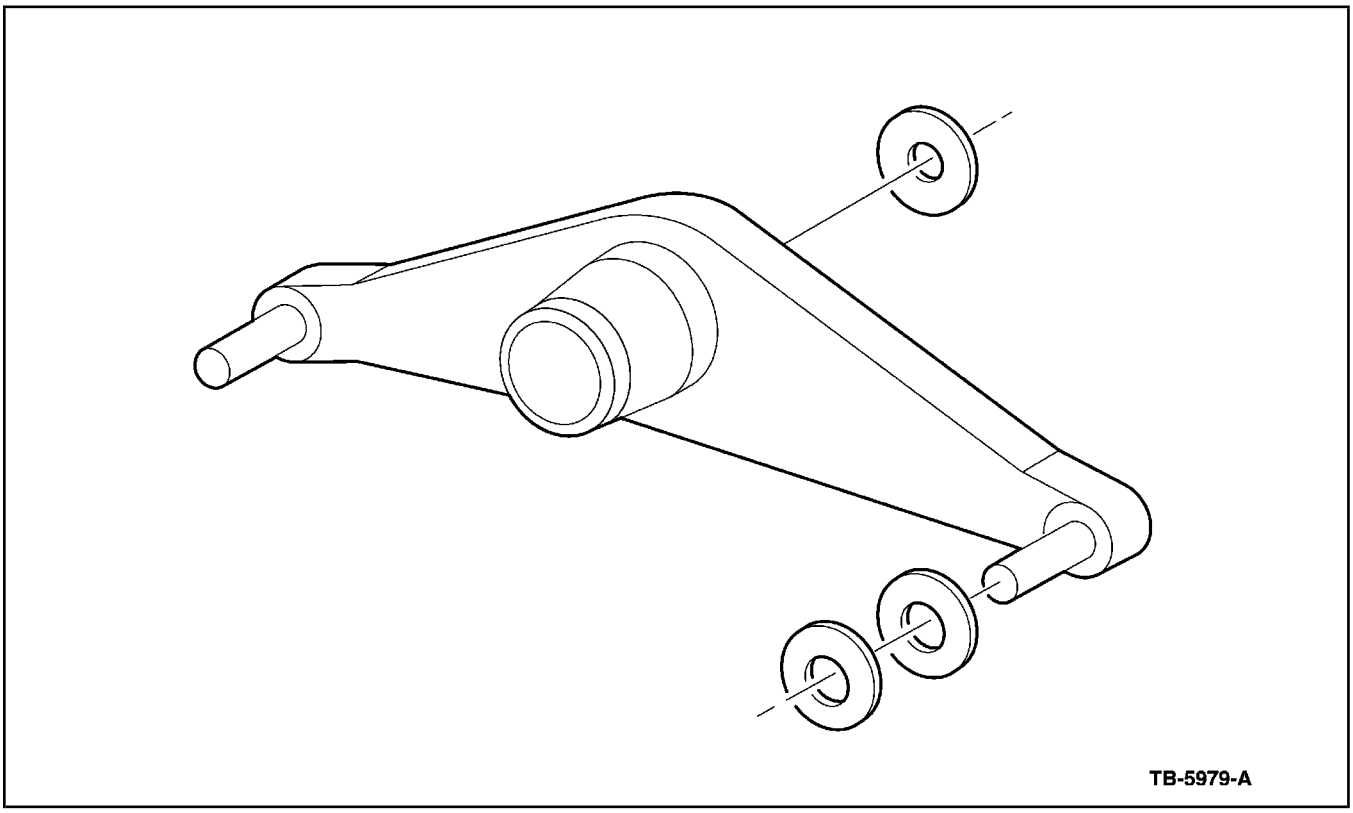
Figure 1 - Article 00-6-6

Some vehicles may exhibit a panel/defrost door "fluttering" noise when the climate control system is in full cool, blower on high speed, and 1 to 2 clicks above panel/floor mode.

Verify that all washers are in place on the banana linkage, install missing washers on the banana linkage, and/or tighten the mounting screw 1/4-1/2 turn. This should reduce the possibility of noise. Refer to the following Service Procedure for details.

1. Locate the banana linkage on the plenum which is located under the driver side instrument panel on the plenum assembly. The banana linkage connects the gear box cam to the panel/defrost door crank on the air handling case (plenum).
2. Inspect the banana linkage and verify that all washers are in place and installed correctly. Two (2) black Washers (44711-S2) should be found between the banana linkage and the door crank. One gold Washer (E830293-S72) should be located under the banana linkage mounting screw. Install any missing washers (Figure 1).
3. If all the washers are present and correctly installed, tighten the banana linkage mounting screw 1/4-1/2 turn until the flutter noise cannot be detected.
4. Verify concern is corrected.
