VILLAGER STEERING GEAR RETAINER BOLT TORQUE CHECK

AFFECTED VEHICLES: ALL 1999 AND CERTAIN 2000 MODEL YEAR VILLAGER

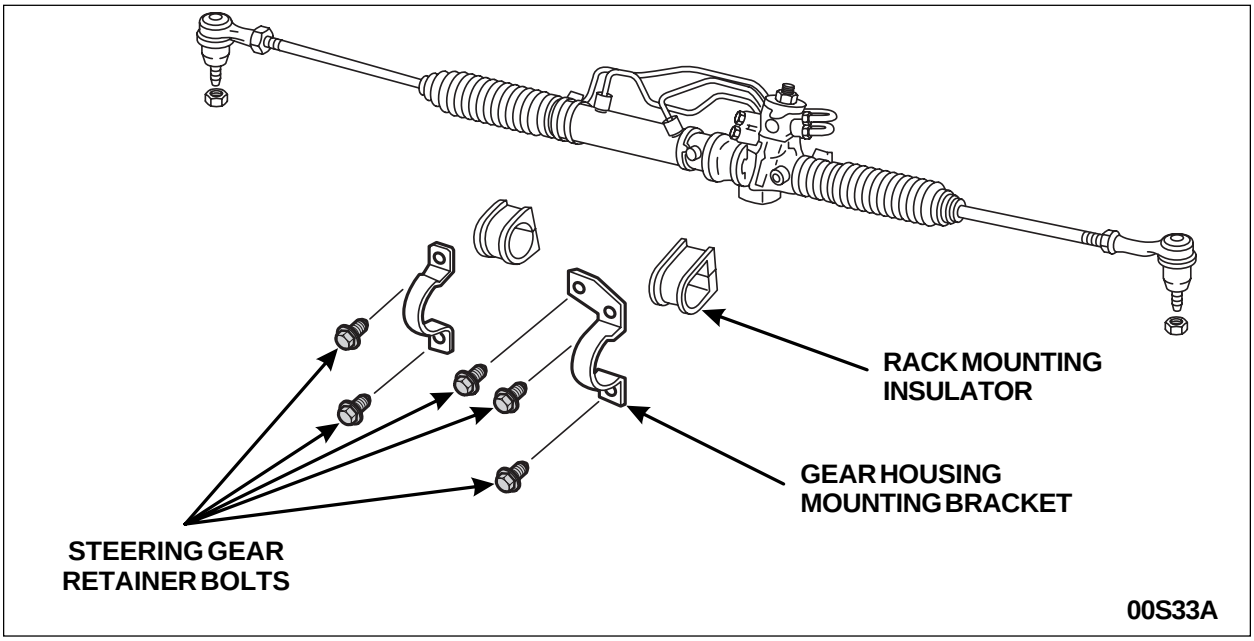
FIGURE 1

This procedure will provide the details to **1)** inspect the five (5) steering gear retainer bolts to see if they are loose (indicated by the bolt turning before the torque wrench reaches the desired torque setting), **2)** inspect the steering gear housing mounting brackets for damage if any bolts are found loose, and **3)** replace the bracket(s) as necessary if damage is found.

1. Raise and support the vehicle on a hoist.
2. Check the torque on each of the five (5) steering gear retainer bolts. The torque specification is 84 Nm (62 lb-ft). See Figure 1.

3. If none of the bolts were loose, no service is required. Lower and release the vehicle.
4. If any bolt is found loose or missing, remove that bolt and inspect the hole in the bracket for signs of damage (hole elongated, paint worn from inside of bolt hole indicating movement of the bracket, etc.). Please note that the right side bracket is manufactured with the upper hole slightly elongated vertically as an aid to assembly. Do not mistake this for damage.

5. If no bracket damage is found, reinstall the bolts. Replace any missing bolts. Tighten the bolts to 84 Nm (62 lb-ft). Then lower and release the vehicle.

6. If either bracket is found damaged, that bracket must be replaced. **DO NOT REMOVE BOTH BRACKETS FROM THE STEERING GEAR AT THE SAME TIME.** Replace each bracket separately with a ***new*** bracket. Replace any bolt that is damaged at the same time.
