CLIMATE CONTROL—MUSTY ODOR FROM CLIMATE CONTROL

Article No. 02-21-15

LINCOLN: 2000-2002 LS

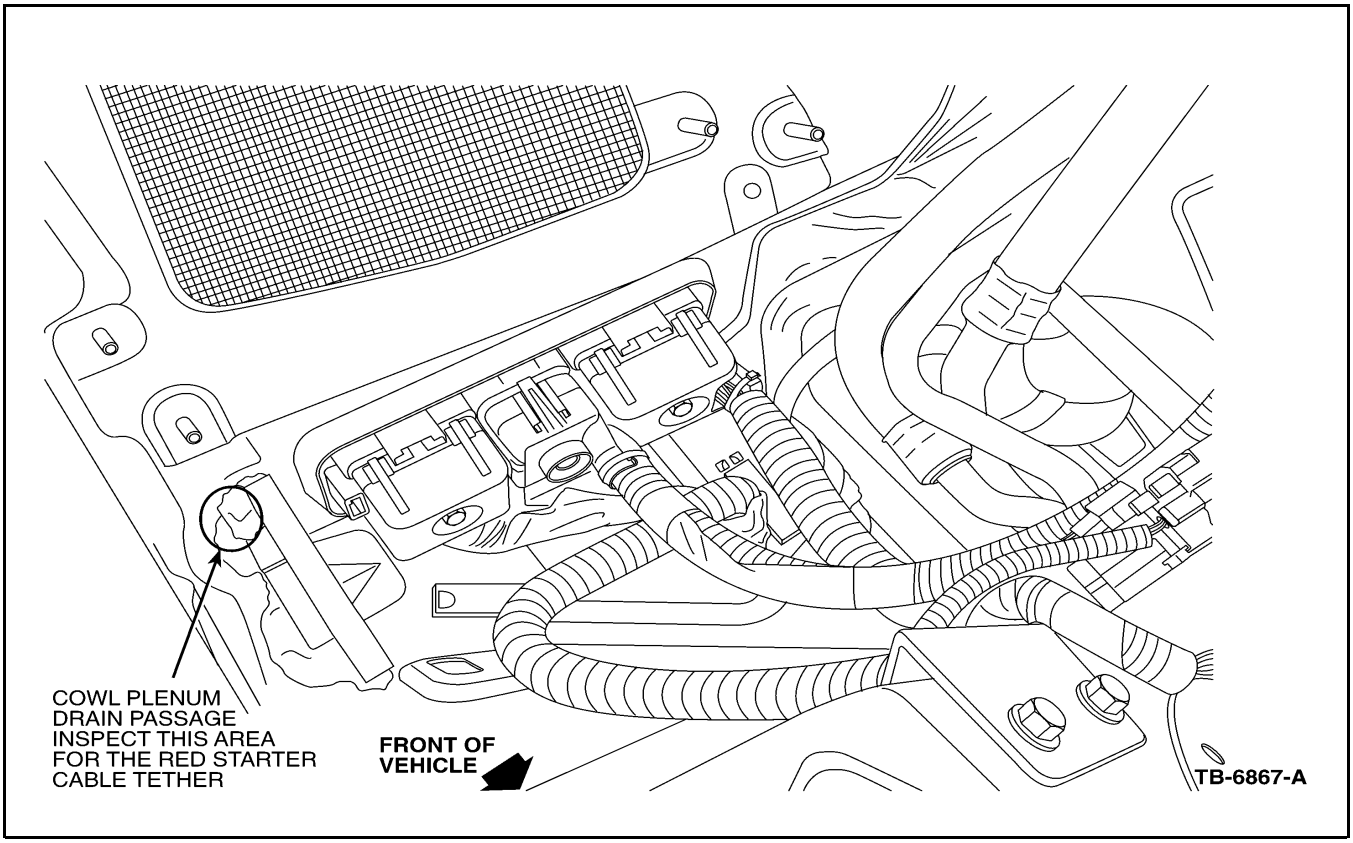
Figure 1 - Article 02-21-15

1. Remove the Fresh Air Inlet Duct. Refer to Workshop Manual, Section 412-01.
2. Inspect the Cowl Plenum Drain Passage for evidence of blockage by the starter cable tether. The tether is red in color and should be plainly visible through the drain passage. Refer to Figures 1 and 2.

3. If the tether is NOT visible, do not continue with this article. It may be necessary to check that the evaporator drain is operating properly (free of blockage) (Figure 1).
