TRANSMISSION—5R55W—FLUID LEAK FROM TRANSMISSION COOLER LINES AT TRANSMISSION CASE CONNECTION—EXPLORER/MOUNTAINEER 4-DOOR VEHICLES BUILT 11/13/2000 THROUGH 4/2/2001 ONLY

Article No. 01-10-2

FORD: 2002 EXPLORER

MERCURY: 2002 MOUNTAINEER

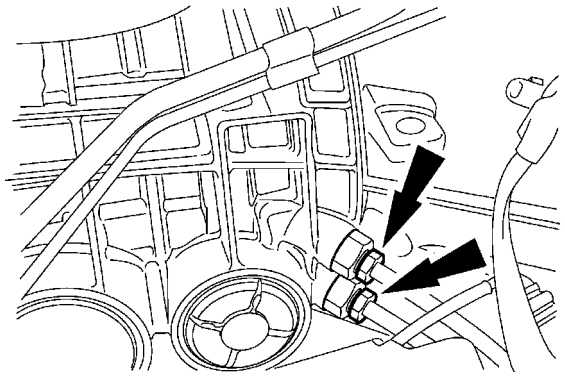
Figure 1 - Article 01-10-2

Some 2002 Explorer/Mountaineer 4-door vehicles built 11/13/2000 through 4/2/2001 equipped with the 5R55W transmission may exhibit a fluid leak at the transmission cooler line-to-transmission case connection. This may be caused by contamination on the cooler tube between the tube nut and flare, contamination on the tube nut threads or improper installation torque.

1. Remove the cooler lines from the transmission (Figure 1).
2. Clean the cooler tube nut threads, clean the cooler lines at the flare and the cooler line surfaces between the line and the cooler tube nuts (Figure 2).
3. Install the service O-rings (W702015-S300) as shown in Figure 3.
4. Reinstall the cooler lines into the case and tighten the cooler tube nuts to 30 N•m (22 lb-ft) (Figure 4).
5. Clean all residual fluid from around the cooler line fittings.
6. Start vehicle and check for leaks.
7. Verify fluid level (refer to the appropriate Workshop Manual, Section 307-01) for proper procedure. Add fluid as necessary.
