BODY—TOP SURFACE OF REAR CARGO DOORS SCRATCHED	Article No. 01-24-7

FORD: 2002 EXCURSION

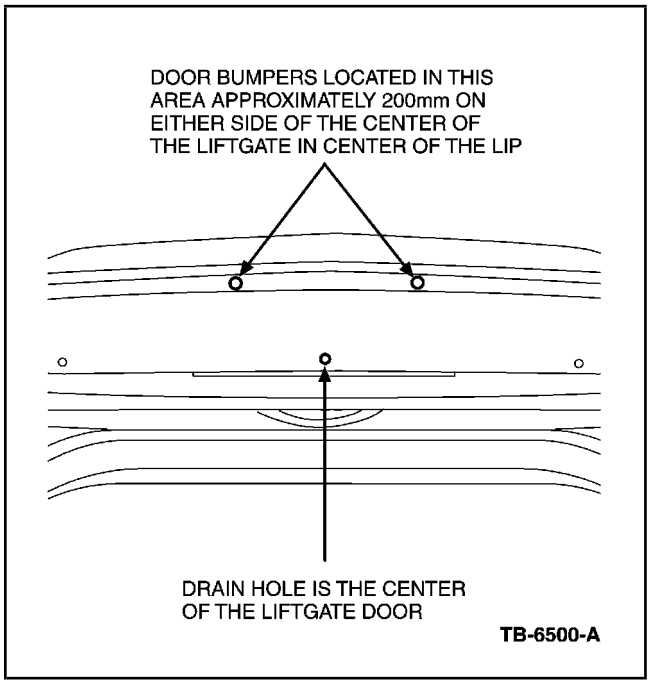
Figure 1 - Article 01-24-7

Some vehicles may exhibit scratching of the top of the cargo doors by the bottom of the liftgate and the applique attached to the liftgate. This may be caused by the cargo door "jumping" when the liftgate is slammed closed or driving over rough roads.

Drill two (2) 5 mm diameter holes into the liftgate 200 mm on both sides of the center of the liftgate in the center of the outer door lip (Figures 1 and 2). Install Door Bumpers part number N805307-S in the two holes using a small blade tip screwdriver.
