• **NOISE—"WHINE" OR "HOWL" NOISE FROM TRANSMISSION AT START-UP—TEMPERATURES BELOW 4 C (40 F)—VEHICLES EQUIPPED WITH 5R55W TRANSMISSION—PRODUCED 11/13/2000 THROUGH 6/15/2001 ONLY** • **TRANSMISSION—5R55W—"WHINE" OR "HOWL" NOISE FROM TRANSMISSION AT START-UP—TEMPERATURES BELOW 4 C (40 F)—PRODUCED 11/13/2000 THROUGH 6/15/2001 ONLY**	**Article No. 01-14-2**

FORD: 2002 EXPLORER

MERCURY: 2002 MOUNTAINEER

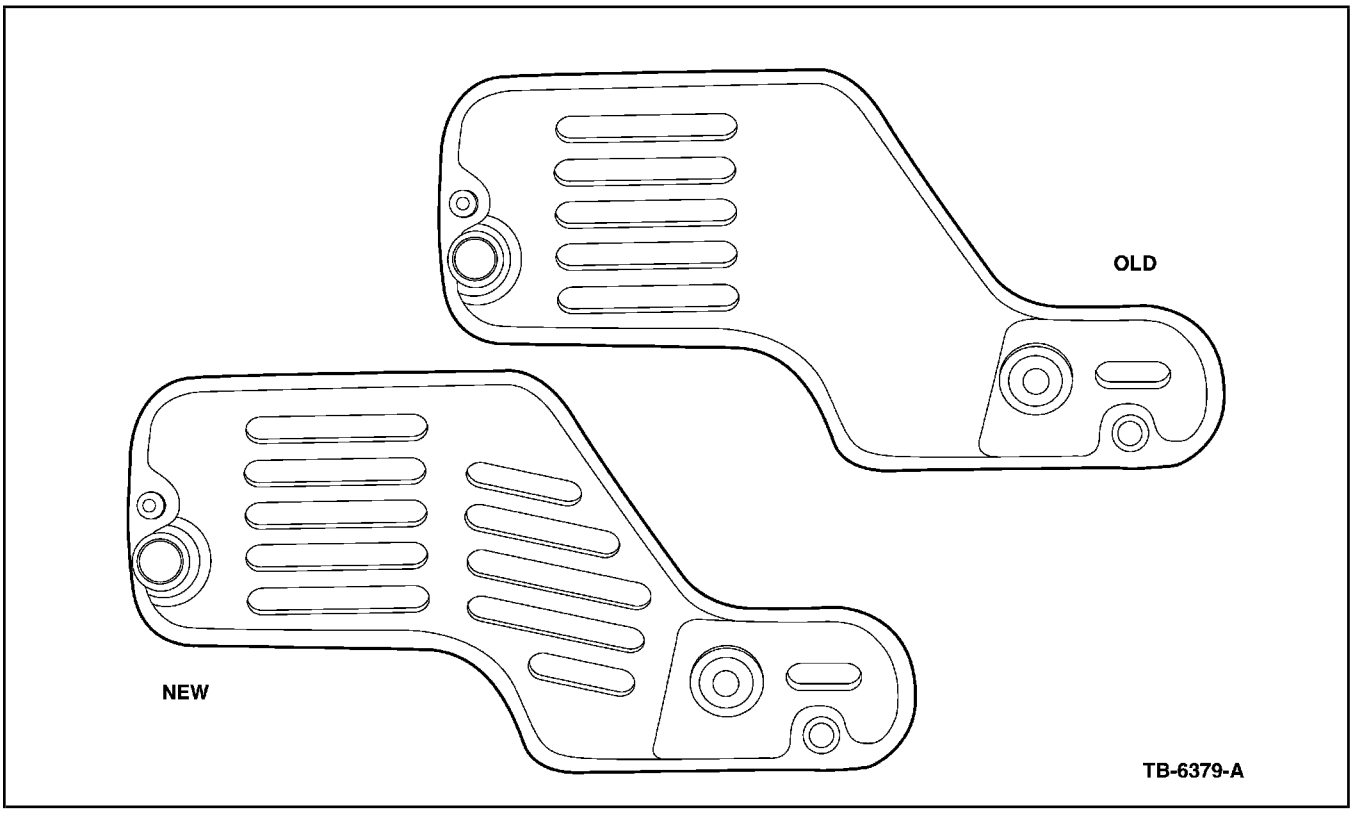
Figure 1 - Article 01-14-2

Some vehicles, built prior to 6/15/2001, may exhibit a "whine" or "howl" noise during cold starts at temperatures below 4° C (40°F). This noise may be caused by the transmission fluid filter.

1. Raise vehicle on a hoist.
2. Drain the fluid from the pan.
3. Remove the pan and gasket.
4. Replace the original filter with the new service filter 1L2Z-7A098-AC (Figure 1).
5. Clean the pan.
6. Reinstall the fluid pan gasket and pan. Tighten the screws in a crisscross pattern to 11 N•m (8 lb-ft).
7. Add fluid and adjust to the proper level, refer to the workshop manual procedure, Fluid Level Check.
8. If the noise is still present after the fluid filter has been replaced, follow normal diagnosis for noise concerns using the Diagnosis by Symptom Charts in the Workshop Manual (Section 307-01).
