• NOISE—"BUZZING" COMING FROM ACCELERATOR PEDAL—4.0L OHV VEHICLES • VIBRATION—VIBRATION COMING FROM ACCELERATOR PEDAL—4.0L OHV VEHICLES	Article No. 00-7-5

FORD: 1999-2000 EXPLORER

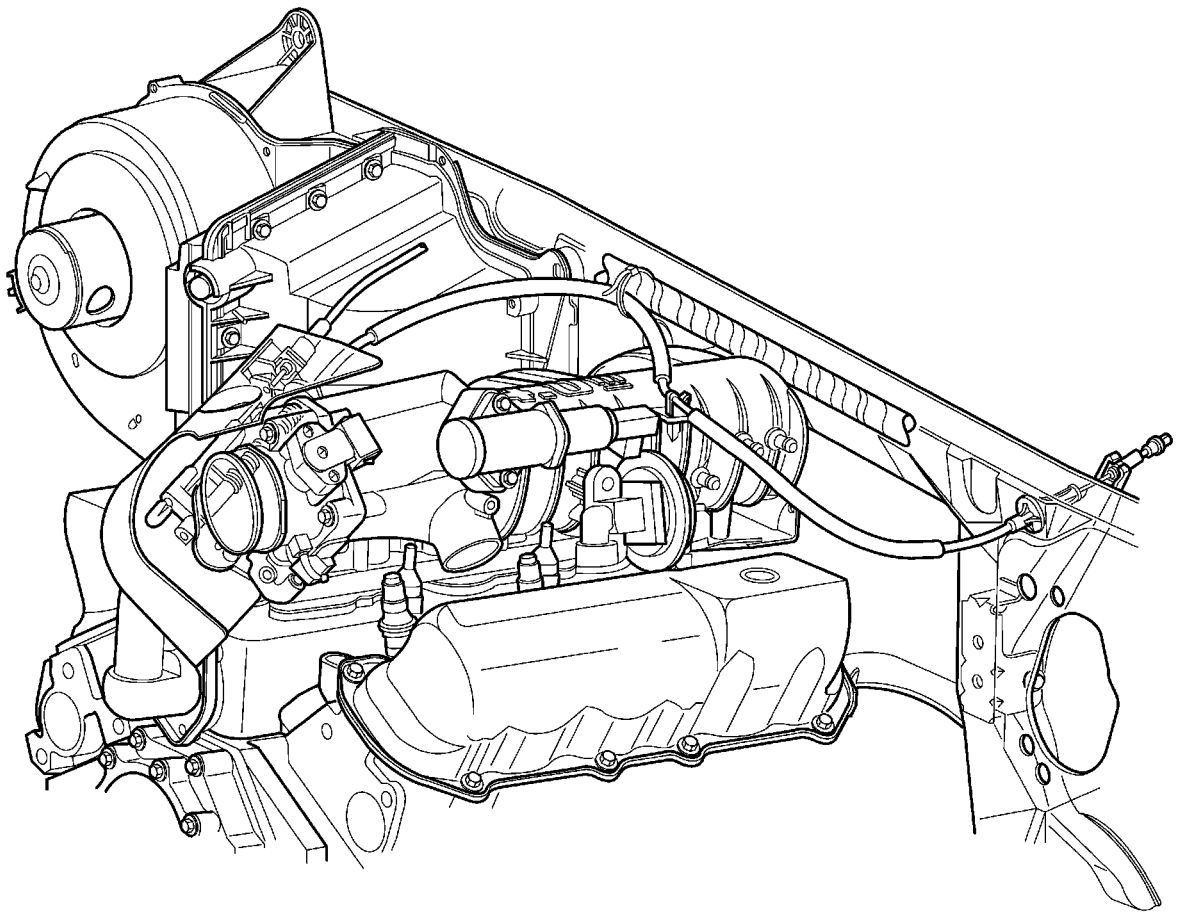
Figure 1 - Article 00-7-5

Some vehicles equipped with a 4.0L OHV engine may exhibit a vibration or buzz at the accelerator pedal. This may be caused by engine vibration that is transmitted through the accelerator cable to the pedal.

1. Attach new Accelerator Cable (F87Z-9A758-KA) on the same plastic retaining clip used with the original cable.
2. Position the cable so that the clip is between the two (2) foam sleeves.
3. Use a tie wrap to loosely attach the cable to the wiring harness which is in the back of the engine compartment as shown in Figure 1.4 of the Workshop Manual.
4. Verify that the condition is resolved.
