• **ENGINE—4.2L—MEXICO VEHICLES ONLY—VIBRATION IN GEAR WITH A/C ENGAGED—VEHICLES EQUIPPED WITH AUTOMATIC TRANSMISSION ONLY** • **VIBRATION—MEXICO VEHICLES ONLY—VIBRATION IN GEAR WITH A/C ENGAGED—VEHICLES EQUIPPED WITH 4.2L ENGINE AND AUTOMATIC TRANSMISSION ONLY**	**Article No. 02-7-1**

FORD: 2000-2001 F-150

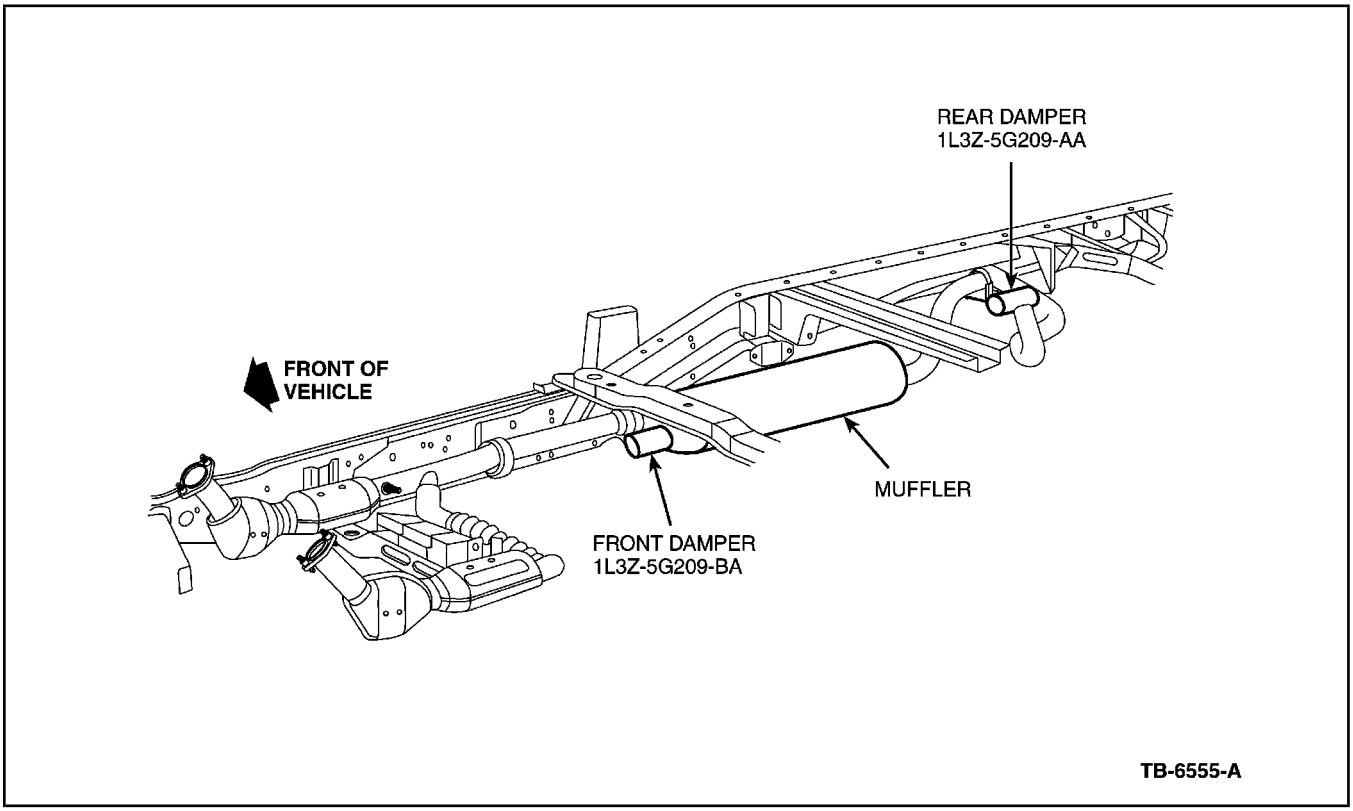
Figure 1 - Article 02-7-1

Some vehicles built at the Cuautitlan Assembly plant equipped with the 4.2L engine and Automatic Transmission, may exhibit a vibration condition when the engine is at idle in Drive and/or Reverse with the A/C turned on. This may be caused by an exhaust vibration condition.

1. Perform the diagnostic self-test to check for Diagnostic Trouble Codes (DTCs). Resolve all codes that are present using the appropriate Powertrain Control/Emissions Diagnosis (PC/ED) Service Manual before proceeding.
2. Verify if contact exist between exhaust system and chassis.
3. Verify the correct engine mounts application as follows:
   - A/T engineering numbers YL34-6038-CA (R.H.) & YL34-6B032-AA (L.H.)
   - M/T engineering numbers YL34-6038-DA (R.H.) & YL34-6B032-DA (L.H.)
4. Make sure that the flywheel and torque converter alignment marks are aligned.
5. Install the Exhaust System Damper 1L3Z-5G209-BA as shown (Figure 1).

IF THE VIBRATION IS STILL PRESENT AFTER THE FRONT DAMPER INSTALLATION, IT WILL BE NECESSARY TO INSTALL A SECOND DAMPER P/N 1L3Z-5G209-AA AT THE REAR OF THE MUFFLER.
